**SERVICE BULLETIN**

SB No. 039

**TITLE** INSPECTION OF WING REAR SPAR TOP SURFACE TO FUSELAGE FAIRING CLEARANCE**CLASSIFICATION** This Service Bulletin has been classified as optional by the U.K. Civil Aviation Authority.**COMPLIANCE** Within the next 150 flying hours, or 3 months from date of this Service Bulletin, whichever is earlier.**APPLICABILITY:**

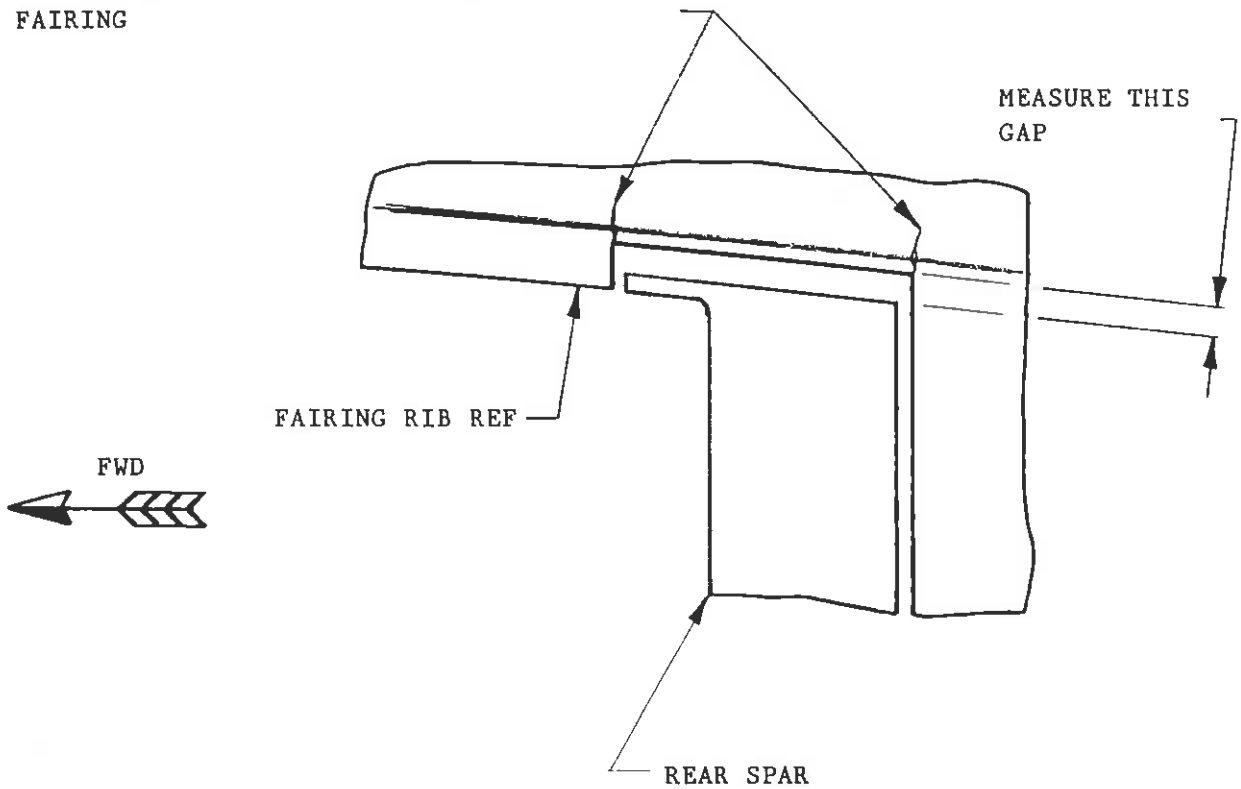
FIGURE 1

A case has occurred whereby the clearance between the wing rear spar top surface and the fuselage fairing has been insufficient to prevent contact at high positive load factors. This has resulted in cracking of the fuselage fairing which, although not structurally significant, is undesirable.

1. Inspect the fuselage fairing for cracking adjacent to the wing rear spar.
2. Measure and record the minimum clearance between the wing rear spar top surface and the fuselage fairing. (Port and starboard) (See Figure 1).
3. Pass details of 1, and 2, above to Slingsby Aviation Ltd.

POSSIBLE AREAS OF CRACKING IN FUSELAGE FAIRING

Rectification action, if required, will be agreed between Slingsby Aviation Ltd and the Customer.
