SERVICE BULLETIN

SB No. 40

TITLE
SPECIAL INSPECTION OF THROTTLE CABLE - T67C AIRCRAFT
CLASSIFICATION

All T67C aircraft pre Mod 480

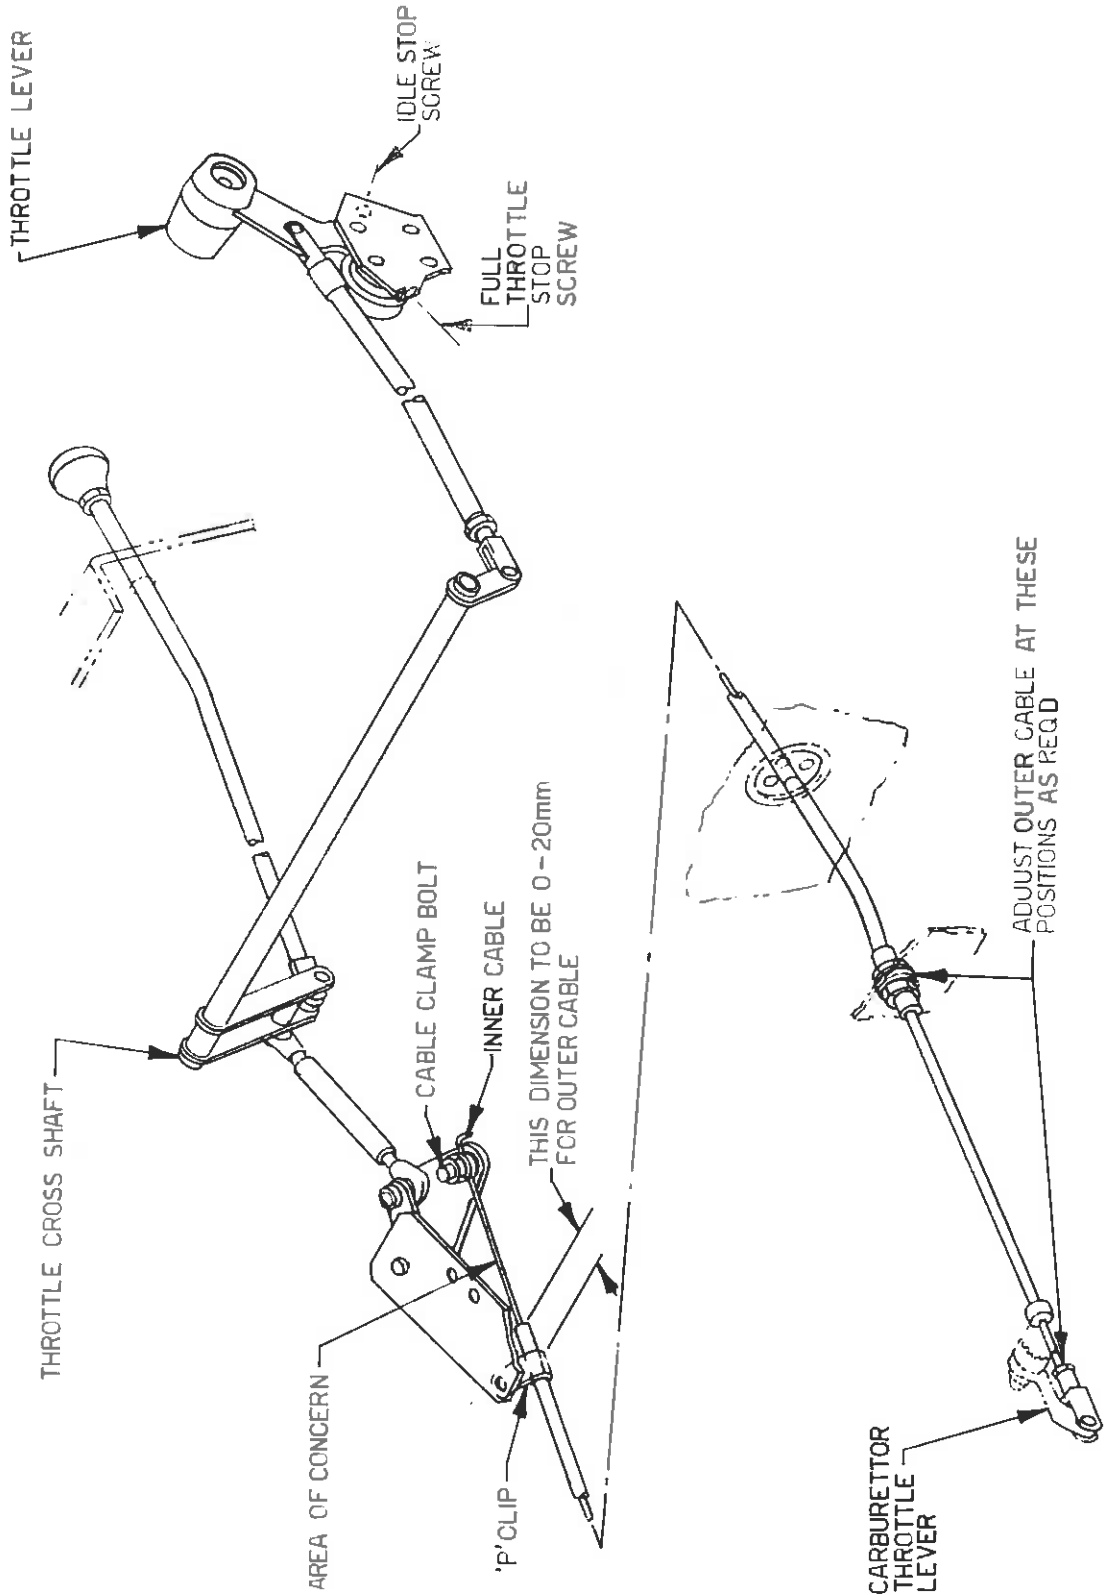
FIGURE 1
(POST MOD M326 DRN)

There have been 2 cases of breakage of the throttle cable on T67C aircraft. In both cases the cable has broken at the cockpit end at a point where the inner cable emerges from the outer cable, see Figure 1.

1. Set the throttle lever to the idle position, and measure the clearance at the idle stop screw.
2. Slacken cable clamp bolt and disconnect the throttle cable at the carburettor.
3. Withdraw the cable about 2 cm. - this ensures that all the affected part of the inner cable will be visible.
4. Visually examine the inner cable for evidence of kinking or cracking - if either is found the cable must be replaced.
5. Check that the length of the outer cable which extends aft beyond the "P" clip, is between 0 and 2 cm. If necessary, adjust the cable position to lie within this tolerance by slackening the "P" clip, repositioning the cable, and retightening the "P" clip. It may be necessary to also adjust the outer cable clamp position at the carburettor end of the cable. When retightening the "P" clip, ensure that it is angled to equalize sideways bending of the inner cable during operation.

6. Set the carburettor to the idle position, and the left hand throttle lever to the position measured in 1. above; retighten the cable clamp bolt.
7. Adjust the full throttle clearance, measured at the throttle lever stop screw, to no more than 1 mm., ensuring that the throttle inner cable between the outer cable termination and the cable clamp bolt is not bowed.
8. Adjust the idle clearance, measured at the throttle lever stop screw to no more than 1 mm.
9. Check that there is no undue play in the throttle cross shaft assembly (play in this assembly would allow the centre throttle action to cause bowing of the inner cable despite correct setting of the throttle stops on the left hand throttle lever).

Carry out items 1,2,3,4, and 6 as detailed above. Check that the clearance as measured at the throttle lever stop screws is no more than 1 mm. at idle and at full throttle.
