SERVICE BULLETIN

52

ELEVATOR HORN WATER INGRESS

All T67 GRP series aircraft.

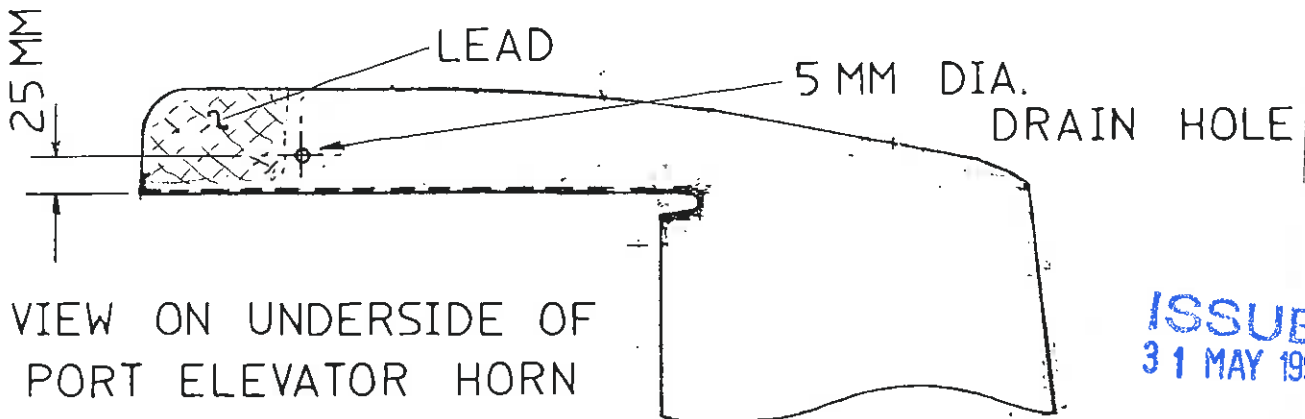
An annual inspection on an elevator had found a quantity of water inside the horn balance.

1. Deflect elevators to up position.
2. By tapping the inside face of the horn balance with a coin, the position of the lead balance weight can be ascertained.
3. Ref. Fig 1 drill 5mm dia hole in the lower skin of the horn in the hollow portion as close to the lead balance as possible.
4. Check the condition of the vinyl disc T67B-00-301 which covers the elevator hinge pivot. Renew as necessary.
