# SERVICE BULLETIN

SB No. 52 Issue No. 3

**ELEVATOR HORN WATER INGRESS**

T67B, T67C Series, T67M, T67M-MkII, T67M200, T67M260 and T67M260-T3A

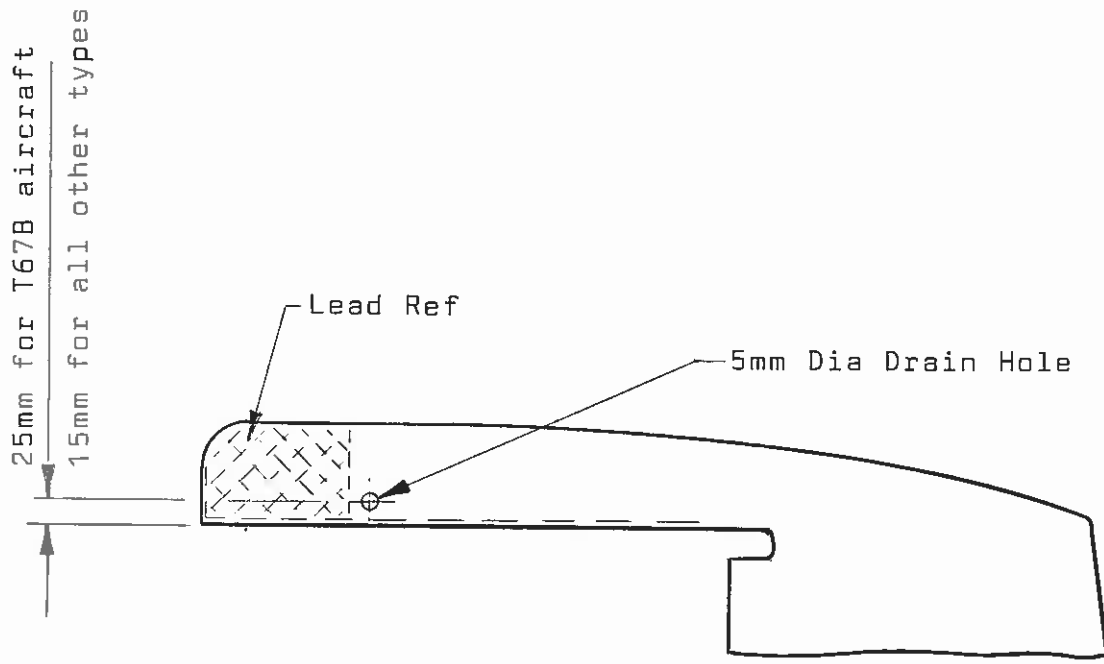
An annual inspection on an elevator had found a quantity of water inside the horn balance.

Fig 1  
View on underside of Port Elevator.  
Stbd similar

1. Deflect elevators to up position.
2. By tapping the inside face of the horn balance with a coin, the position of the lead balance weight can be ascertained.
3. Ref. Fig 1 drill 5mm dia hole in the lower skin of the horn in the hollow portion as close to the lead balance as possible.
4. Check the condition of the vinyl disc T67B-00-301 which covers the elevator hinge pivot. Renew as necessary.
5. Annotate logbook SB 52 complied with. Invokes Mod M606.
