# SERVICE BULLETIN

SB No. 68 Issue No. 5

**TITLE**
**CANOPY LATCH CORRECT OPERATION INSPECTION**
**CLASSIFICATION**

T67M-MkII, T67M260, T67M260-T3A and any T67C, T67M and T67M200 Aircraft Post Mod M129/M129B (Split Canopy),

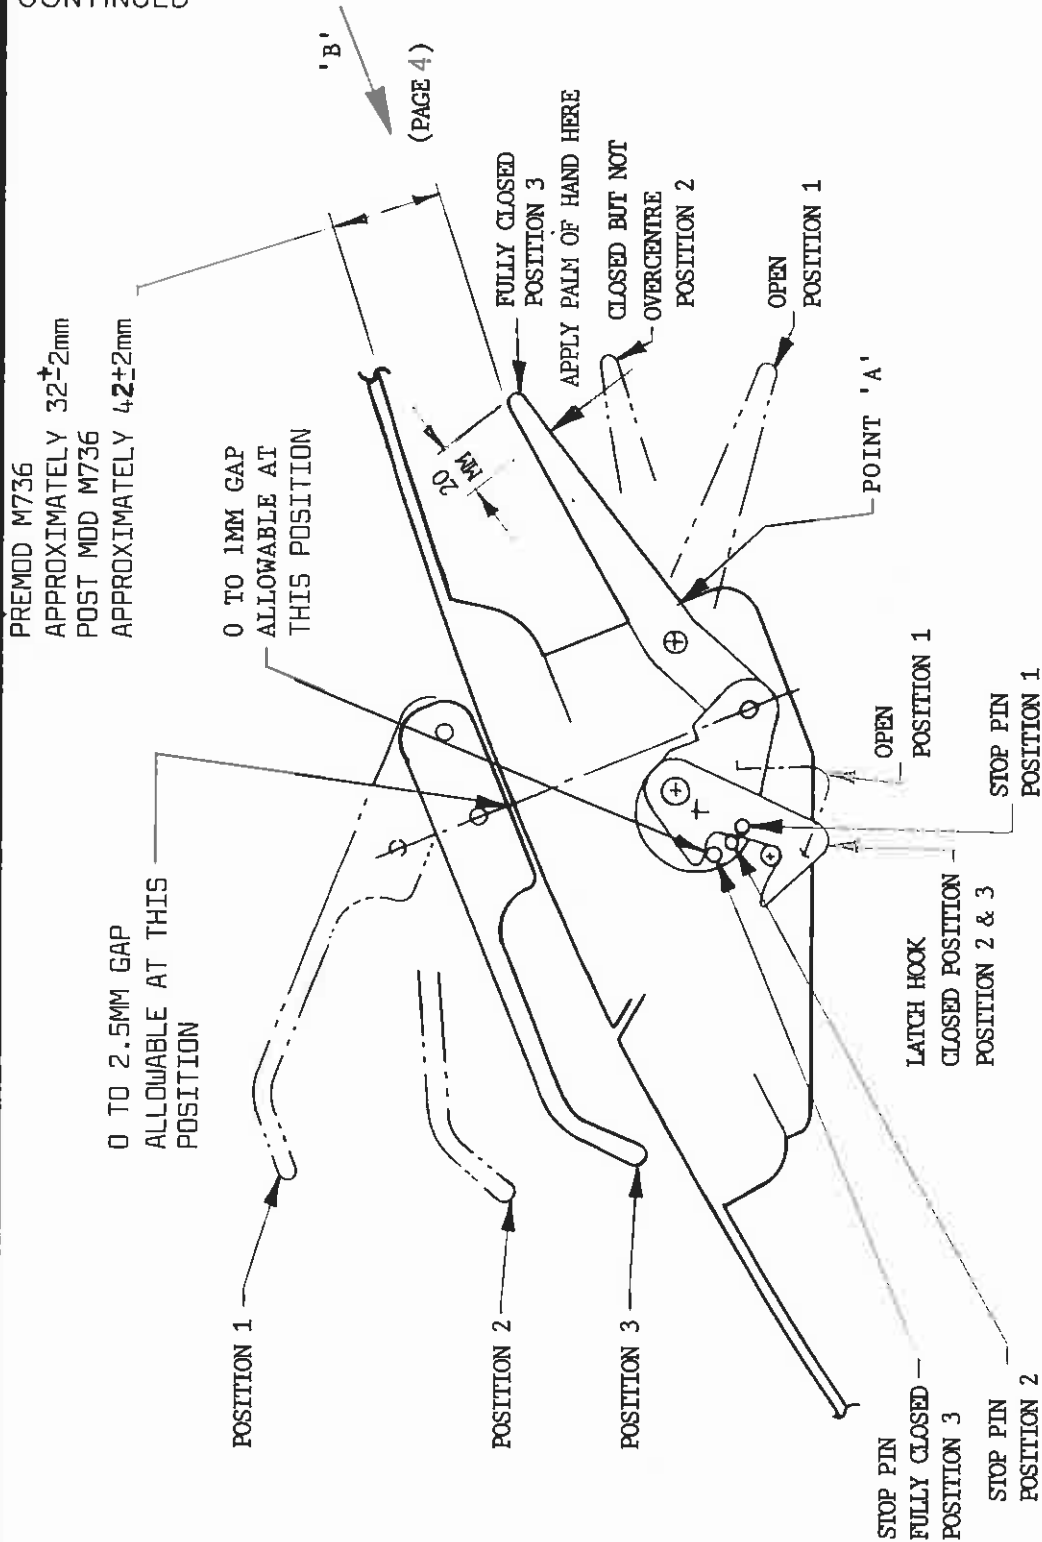
Fig 1

Fig. 1 page 2 shows 3 positions of the canopy mechanism:

Position 1 - Open/Unlatched

Position 2 - Latched but mechanism not over centre

Position 3 - Correctly closed, mechanism fully over centre.

- (i) Remove canopy mechanism and latch covers
- (ii) Close canopy fully. Ensure internal handle is in its correct position and external handle is in its correct position, ie touching bush or no more than 2.5mm gap. Fig. 1.

- (v) Check closure. By positioning palm of hand at point indicated, ref. Fig. 1, push up latch handle, which should close with reasonable resistance but without using excessive force.
