Service Bulletin

S.B. No: 82

Title: INSPECTION OF WING WALKWAY AREAS

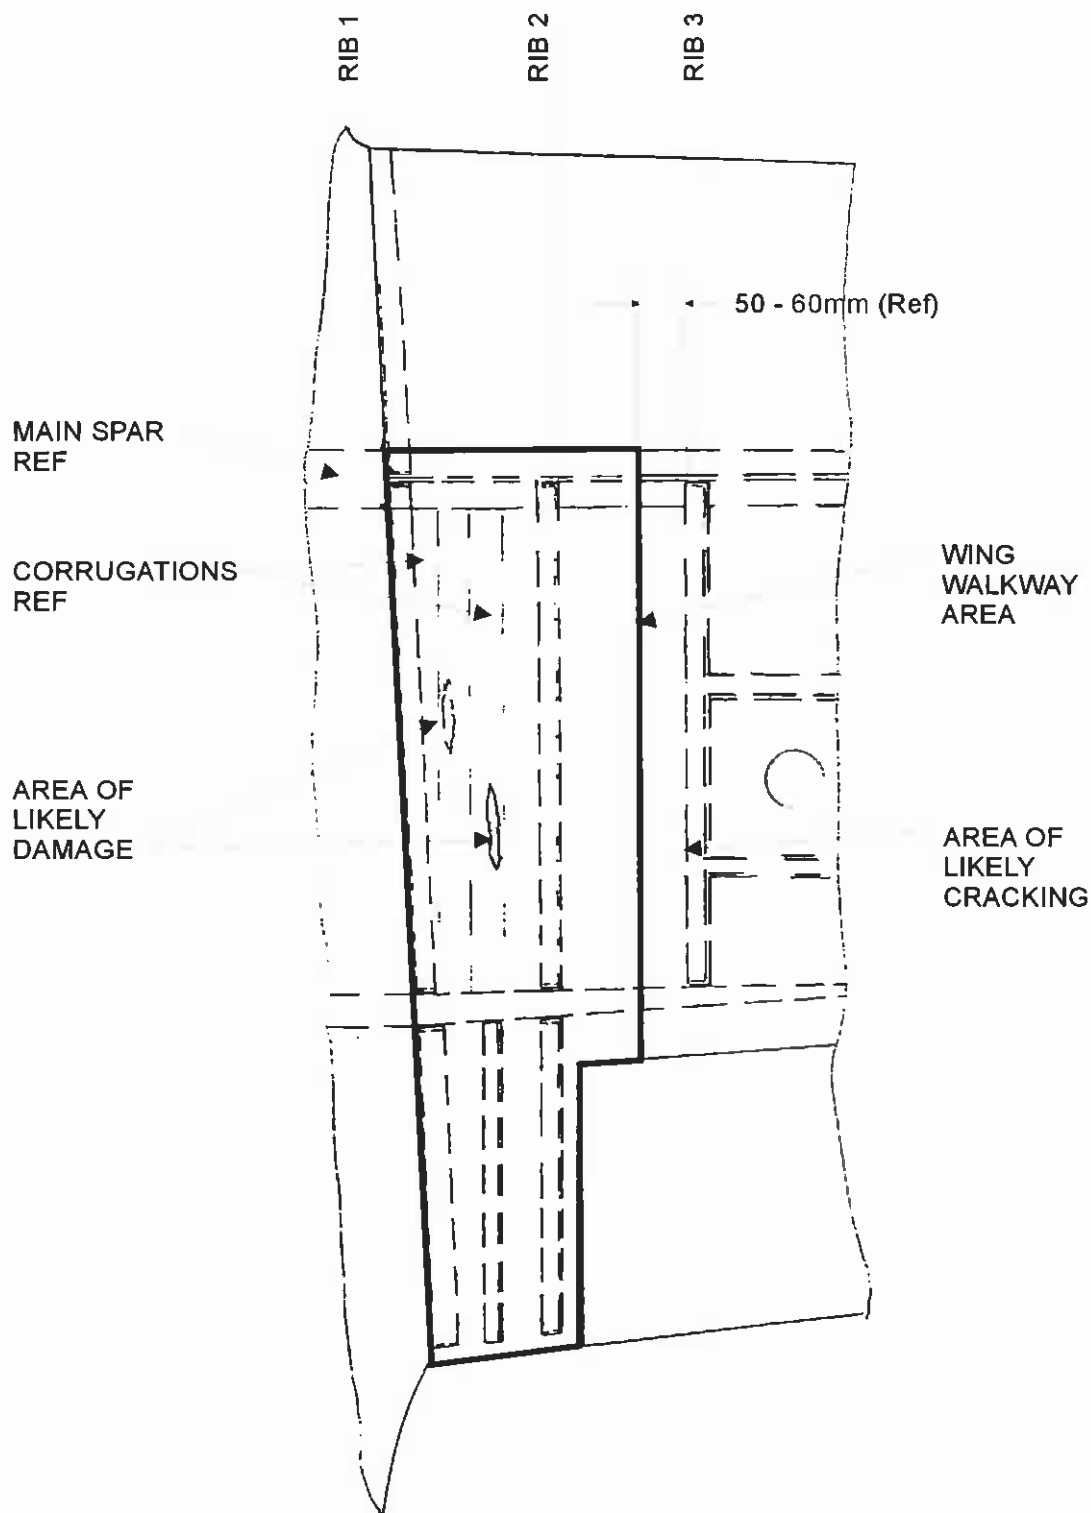
FIGURE 1 STBD (RH) DRN – PORT (LH) SIMILAR

Two cases have been reported of delamination in the skin and corrugations in the area of the wing walkway. Reference Figure 1.

Subsequent to Issue 2, cracking inboard of Rib 3 flanges has been reported.

1. At next 150 (or 100 for US registered aircraft) flying hour check, reference Figure 1:
 - i. Visually inspect wing walkway area by either viewing through flap drive access hole in undersurface of wing or through Rib 1 (seats out). Also press down over wing walkway area: there should be no signs of delamination on corrugation or "spongy" feel to walkway.
 - ii. Inspect for cracking in region of Rib 3, by pressing down slightly inboard of the rib and noting any relative movement of skin.
2. If the wing is not damaged, refer to Action Matrix Reference # 1.
 - ii. If the fluid lines are leaking at the clamp positions, replace.
 - iii. If the fluid lines feel soft when squeezed, replace.

- iv. If the fluid lines do not appear to have a yellow cast, replace.
- v. If in doubt, replace.
3. If the wing walkway area is found to be suspect or has damage, remove wing walk tape and surface finish to ascertain degree of damage. Wing walkway tape is to be carefully removed by removing wing seal, lifting corner of wing walk tape and pulling back applying gentle heat at the base of the lifted tape. Ensure the heat source is not stationary at any one point.
4. If there is damage to the wing walk way skin or corrugation refer to Action Matrix References # 2 – 5 and 8 for action to be taken.
5. If there is damage/cracks at Rib 3 then refer to Action Matrix References 6 – 8 for action to be taken.
