# SERVICE BULLETIN

SB No. 83 Issue No. 1

**TITLE INSPECTION FOR FOUL BETWEEN NO.2 RUDDER PEDAL PAD PIVOT AND NOSEWHEEL STEERING ROD ARM**

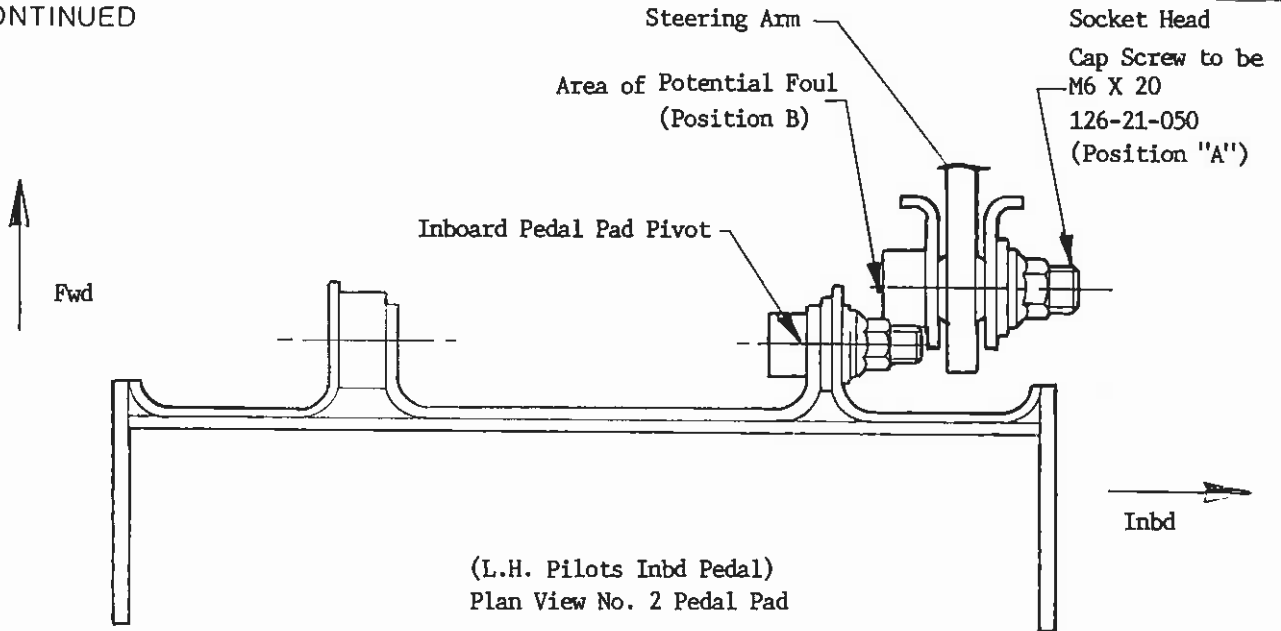
FIG 1

Cases have been reported during the build of the T-3A variant of the Firefly, of a potential foul between the No.2 pedal (left hand pilots inbd pedal) inboard pivot bolt tail and head of nosewheel steering rod arm attachment bolt.

This foul is to be found at extreme forward pedal adjustment full rudder deflection.

Additionally a case has been reported of a short bolt having been fitted at the nosewheel steering rod to arm attachment. The consequence of this is that the nut may not be properly locked.

1. At Position 'A', check that bolt at nosewheel steering rod arm attachment measured 20mm long measured from under head. If not replace with M6 x 20 126-21-050, Ref Fig. 1, orientated as shown.
2. At Position 'B', with No.2 pedal fully adjusted forward and with full right rudder check for clearance between bolt tail and bolt head Ref Fig. 1.

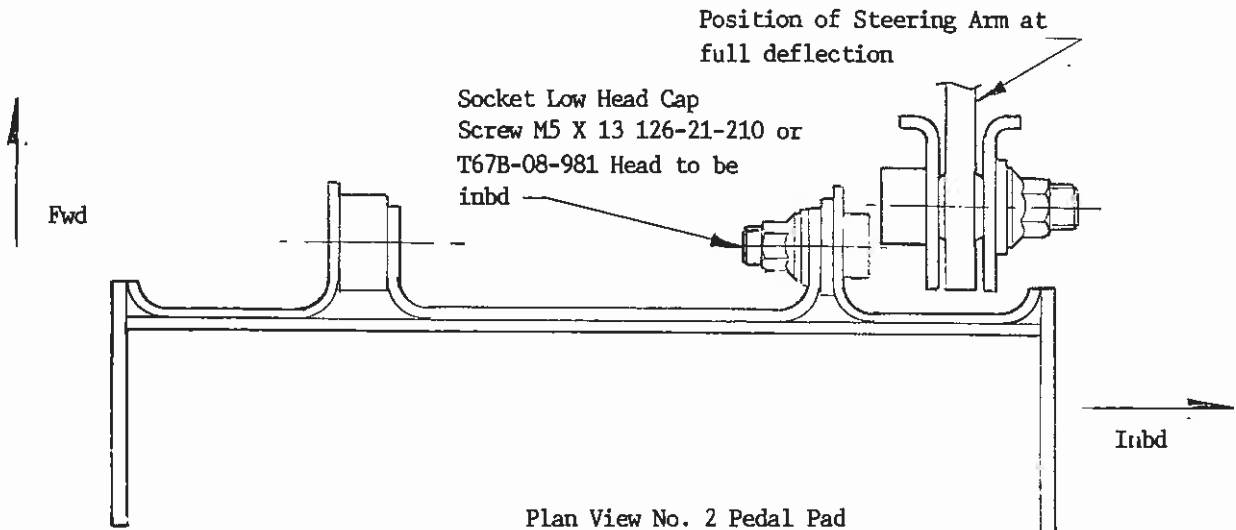
FIG 2

Plan View No. 2 Pedal Pad

3. If 1mm or more clearance is shown with pedal mechanism on its stop together with correct rudder deflection with all backlash taken up to minimise the clearance, annotate in Log Book "SB 83 carried out".
4. If clearance is less than 1mm, or touching:
  - i) Replace existing socket head cap screw indicated on Fig. 1. With socket head cap screw 126-21-210 (or T67B-08-981) as shown in Fig. 2. Ensure correct rudder operation and deflections.

The fitting of socket head cap screw 126-21-210 (or T67B-08-981) invokes Mod M671.
  - ii) Annotate aircraft log book "SB 83 carried out" and "Mod M671 incorporated".
5. At each rudder pedal dis-assembly/re-assembly and re-rig, ensure conditions at 2. are met, until Mod M671 at 4 i) is incorporated.
