# SERVICE BULLETIN

SB No. 94 Issue No. 1

**TITLE** INSPECTION OF ELEVATOR PUSHROD TO CONTROL COLUMN ASSEMBLY  
PIVOT BOLT TO SEAT CLEARANCE

T67M260-T3A Pre Mod M695 aircraft.

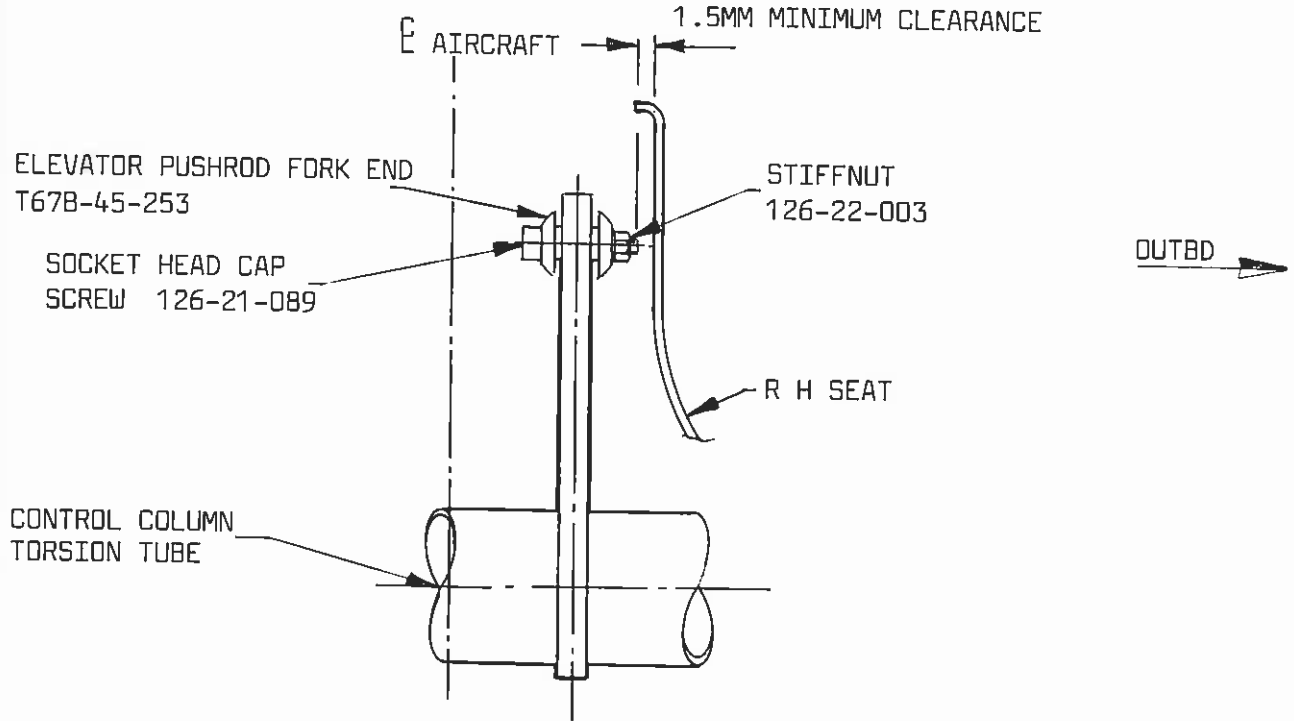
FIG 1  
VIEW LOOKING FORWARD

A case has been reported of the elevator pushrod to control column assy pivot bolt tail, rubbing the right hand seat.

1. Compliance A: Check if bolt is rubbing, if so proceed as per paragraph 4.
2. Compliance B: Remove centre console and check bolt tail or bolt head to seat side clearance Ref Fig. 1. Clearance to be a minimum of 1.5mm.
3. If clearance is 1.5mm or more, annotate logbook SB 94 complied with.
4. If clearance is less than 1.5mm then proceed as follows:
  - i. Remove right hand seat.
  - ii. Remove bolt.
  - iii. Obtain new bolt 126-21-211 and assemble with head to R.H. side, Ref Fig. 2.
  - iv. Reassemble seat and console.
  - v. Annotate in logbook SB 94 complied with and Mod M695 incorporated.
