SERVICE BULLETIN

SB No. 96 Issue No. 1

TITLE
INSPECTION AND REPLACEMENT OF TRIM WHEEL THRUST WASHERS
CLASSIFICATION

T67C Post Mod M443, T67M260 and T67M260-T3A.

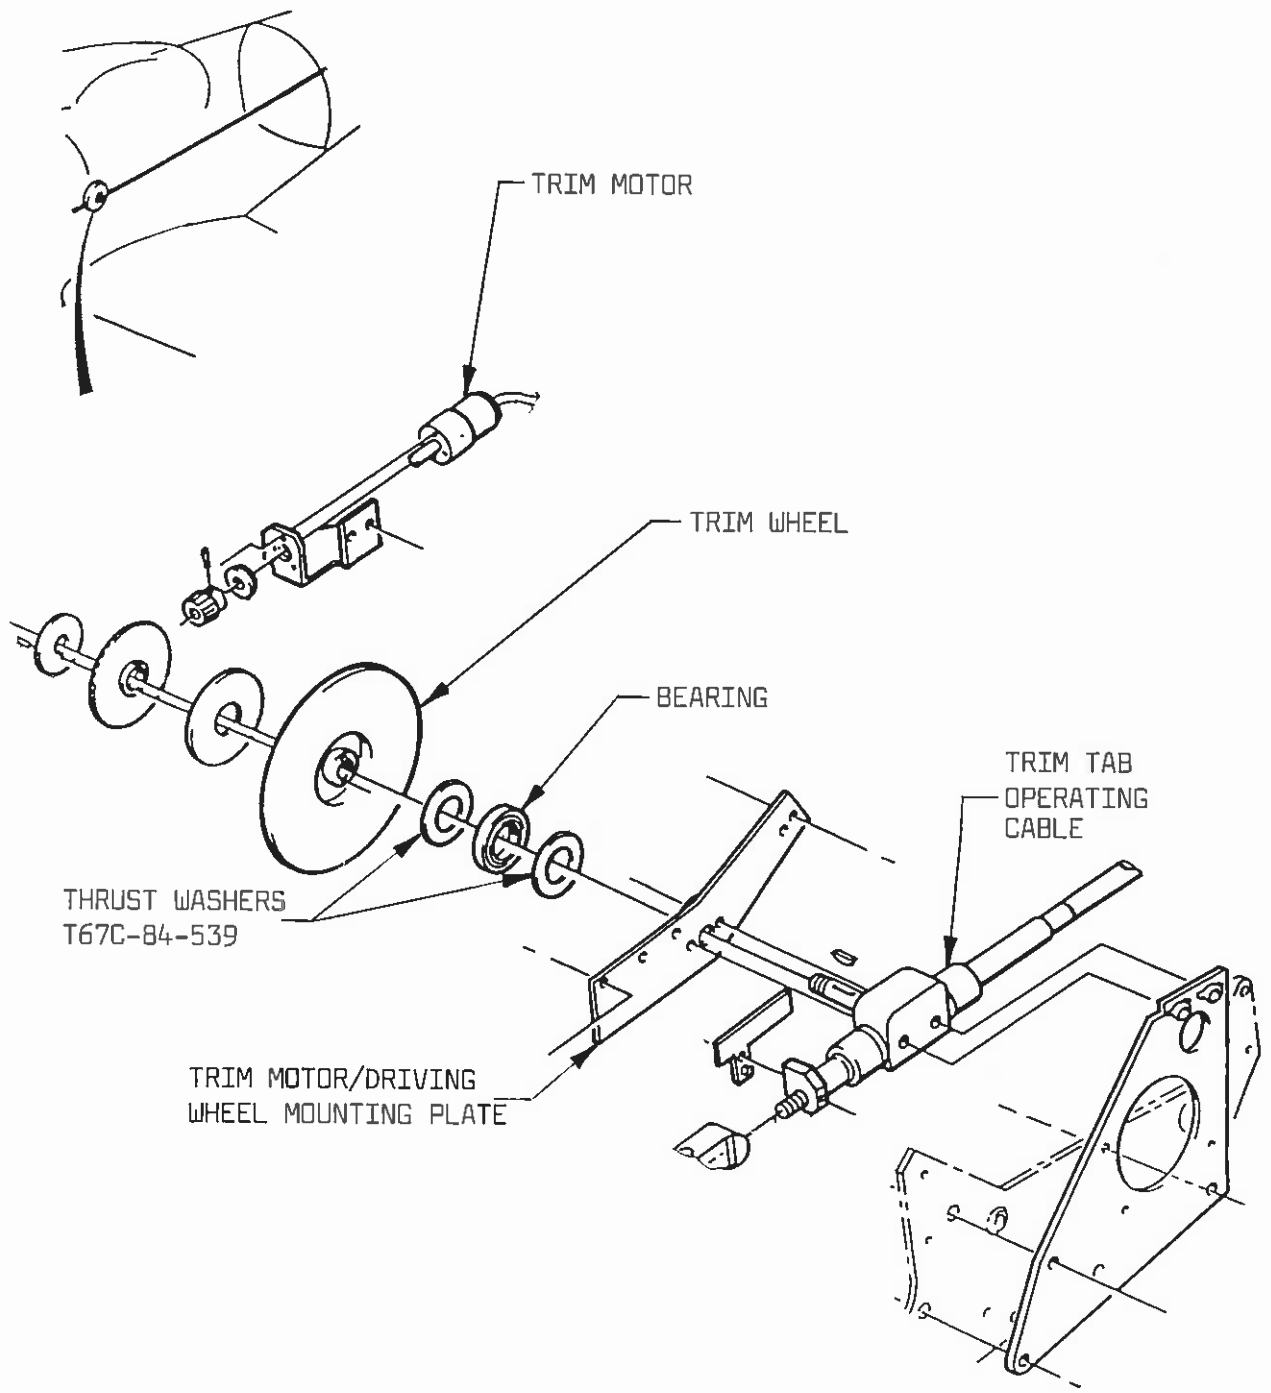
FIG 1
ELECTRIC TRIM DRIVE
THRUST WASHER LOCATION

1. Gain access to trim motor and its thrust washers. Ref. Fig. 1.
2. Remove thrust washers.
3. Inspect thrust washers for the following:
 - i) Indentations, ref Fig. 2. If any found, replace with new component.
 - ii) Excessive grooving, ref Fig. 3. If groove measures greater than 1mm wide, replace with new components. Partial grooving is acceptable provided the grooved area is not wider than 1mm, ref Fig 4.

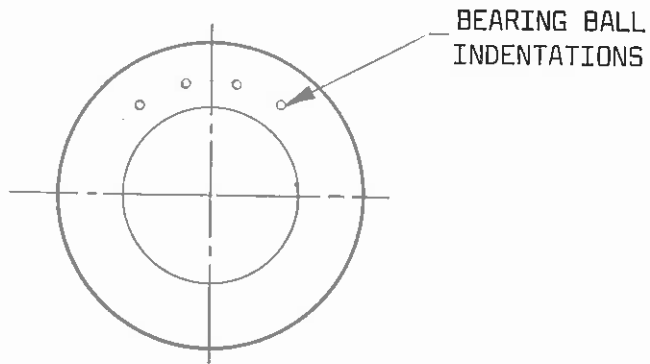
Upon investigation, it was found that if the trim wheel retaining nut is overtightened, indentations are forced into the stainless steel thrust washers by the thrust bearing. A consequence of the overtightening is that a braking action is applied to the trim motor causing the motor to overload.

FIG 2
THRUST WASHER INDENTATIONS

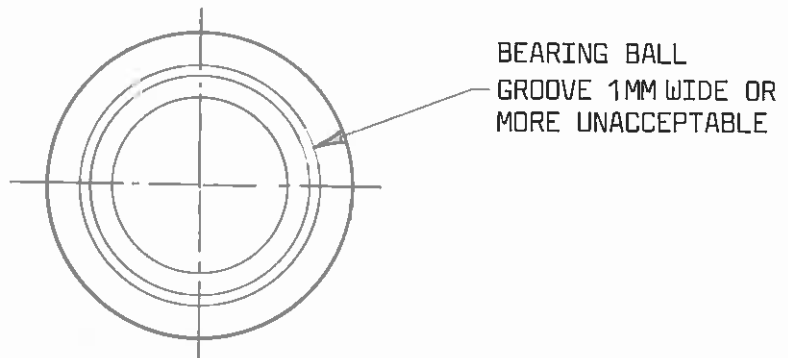
FIG 3
THRUST WASHER GROOVE

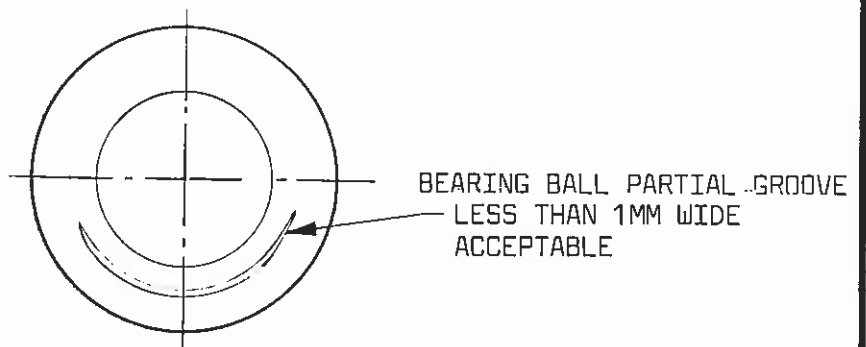
FIG 4
THRUST PARTIAL GROOVE
