SERVICE BULLETIN

SB No. 102 Issue No. 1

TITLE INSPECTION OF AND WIRING OF ROLL PIN ON FUEL SELECTOR TORQUE TUBE

T67M260 and T67M260-T3A.

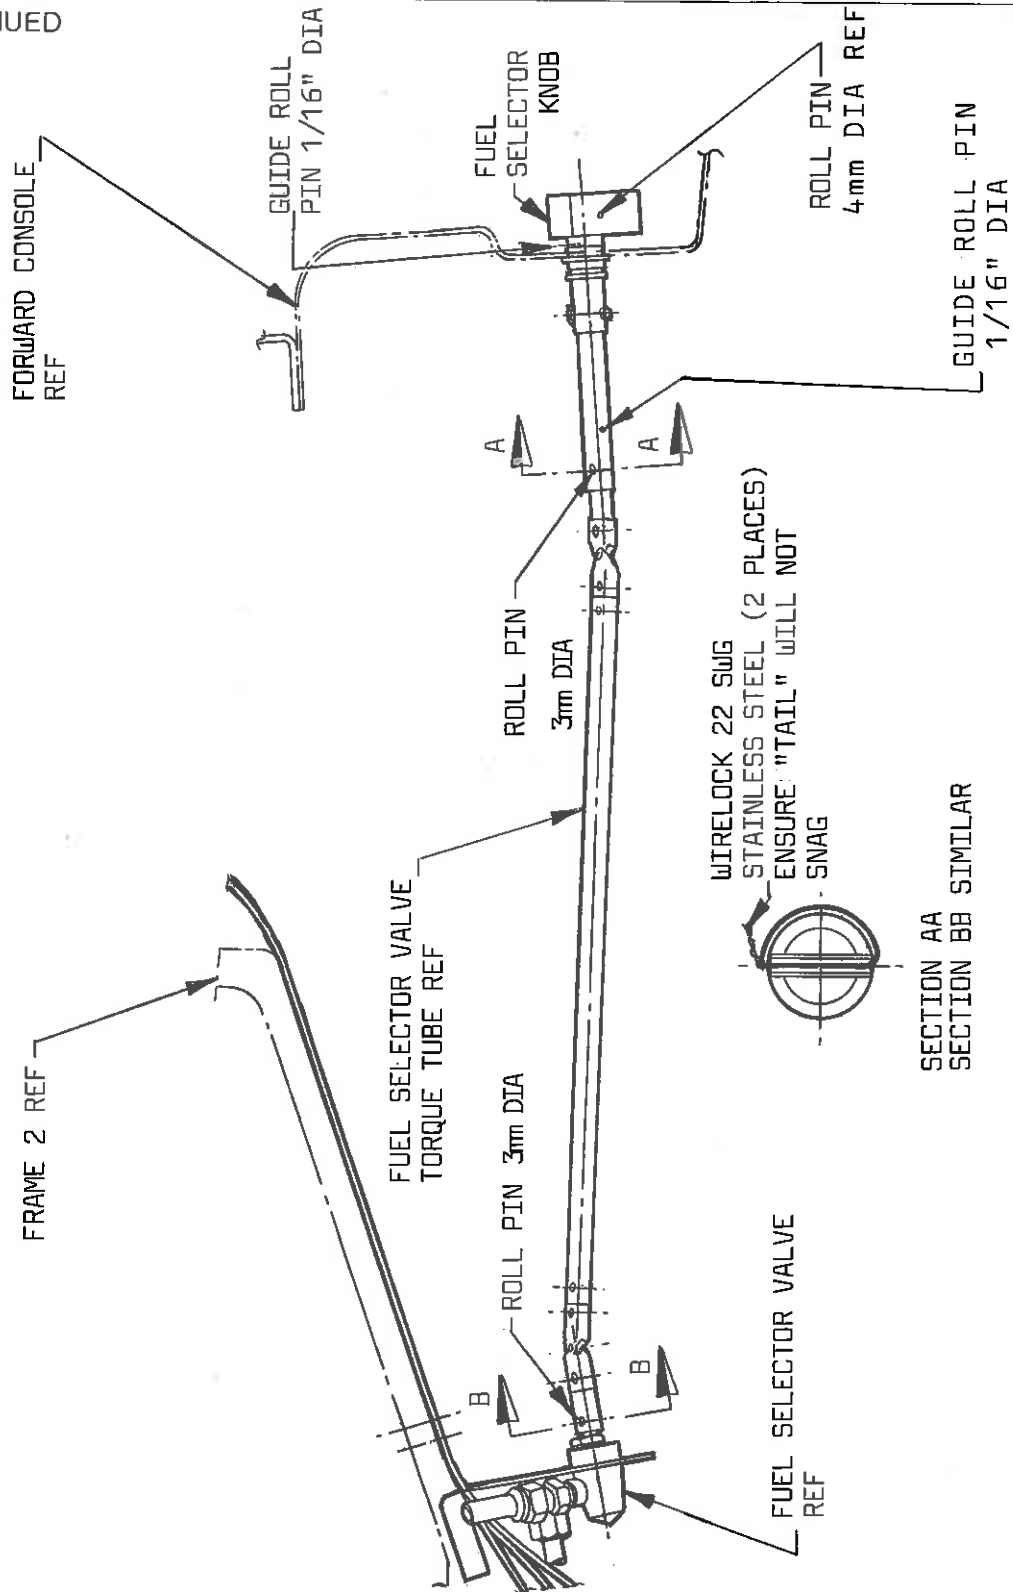
FIG 1

A case has been reported of the roll pin, which secures the fuel selector torque tube adaptor to the fuel selector torque tube, having dropped out. As a consequence to this when the fuel selector knob was operated the guide pin took all the load and sheared.

On reassembly, with a new roll pin, the torque tubes were assembled 180° out, as a consequence of the missing guide pin having not been replaced. Subsequently during flight the pilot could only select one tank.

Investigation revealed that some aircraft assembled in the USA had the drive roll pin holes too large at 0.125" instead of 3mm.

1. Inspect the two roll pin positions, Sections AA & BB of Fig. 1, for missing, loose, distorted or broken pins. If the pins can be turned in the hole, remove pin and check the hole size. For 3mm hole, replace with new pin existing Part No. 126-25-012. If hole is larger (for 0.125" dia use different roll pin Part No. 126-25-411). If hole is greater than this consult SAL for correct part number or action as replacement items may be required.

2. Check that guide roll pins 126-25-406 2 positions indicated in Fig. 1 are not damaged or loose. These are to be replaced if fault found.
3. Insert wire locking 120-08-012 (22 swg) through roll pins indicated at Sections AA and BB of Figure 1.
4. Ensure fuel selections can be correctly obtained.
5. On completion annotate logbook "SB 102 complied with" and i) "Mod M712A incorporated" , if wirelocking only incorporated, or ii) "Mod M712B incorporated", if wirelocking and 1/8" dia pins (126-25-411) added, ref Action 1.
