# SERVICE BULLETIN

SB No. 104 Issue No. 1

<b>TITLE</b>	<b>INSPECTION OF BONDING BRAID FROM FLAP TORQUE TUBE PIVOT TO AFT SEAT MOUNTING TUBE LOWER BOLT</b>
<b>CLASSIFICATION</b>	This Service Bulletin has been classified by SAL as Highly Recommended
<b>COMPLIANCE</b>	Inspect i.a.w. this SB within 50 flying hours then as para 2. i)-iv) until Mod M721 invoked
<b>APPLICABILITY:</b>	
T67B, T67C Series, T67M, T67M-MkII, T67M200, T67M260 (Pre Mod M721) and T67M260-T3A (Pre Mod M721)	
<b>INTRODUCTION:</b>	
A case has been reported of a broken bonding braid. The braid links the flap torque tube pivot to aft seat mounting tube lower attachment bolt, both port and starboard.	
<b>ACTION</b>	
<ol style="list-style-type: none"> <li>1. Gain access to flap drive in centre console.</li> <li>2. Inspect bonding braid, Part Number T67B-81-549, for integrity, ref Fig. 1.           <ol style="list-style-type: none"> <li>i) If either bonding braids are broken, then new braids are to be fitted ref Mod M721 within 50 flying hours.</li> <li>ii) If 50% and over of the braid is damaged, then replace with new braid, Post Mod M721, within 100 flying hours.</li> <li>iii) If less than 50% of the braid is damaged

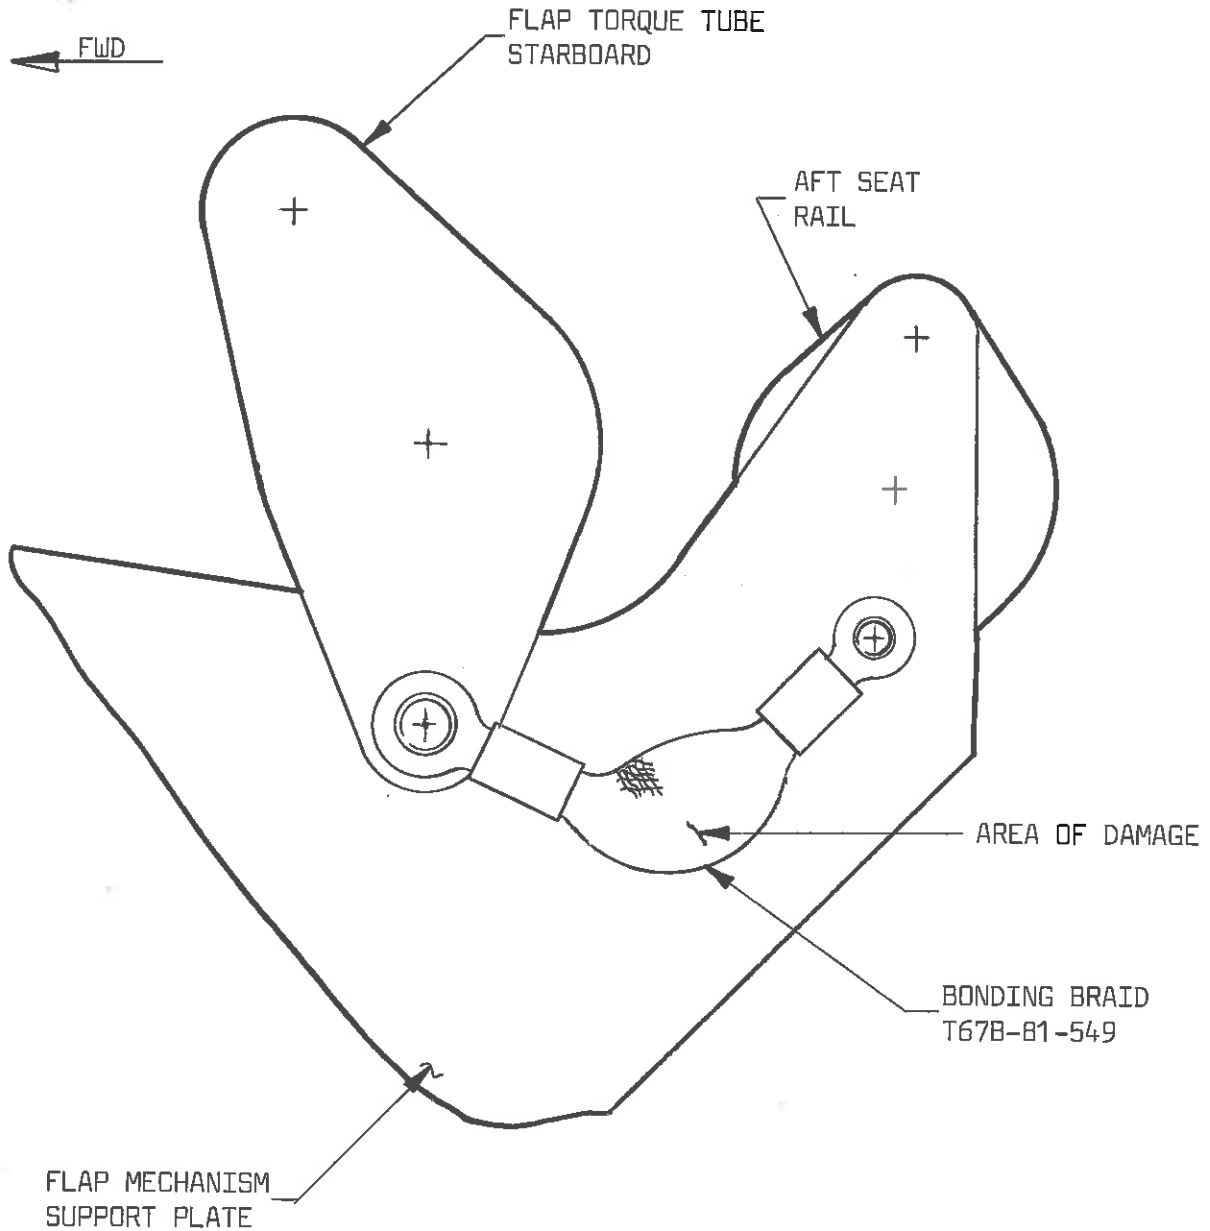
FIG 1

VIEW ON FLAP MECHANISM SIDE PLATE STARBOARD PORT SIMILAR
