SERVICE BULLETIN

SB No. 107 Issue No. 1

TITLE INSPECTION OF PILOTS MIXTURE LEVER

T67M260 and T67M260-T3A.

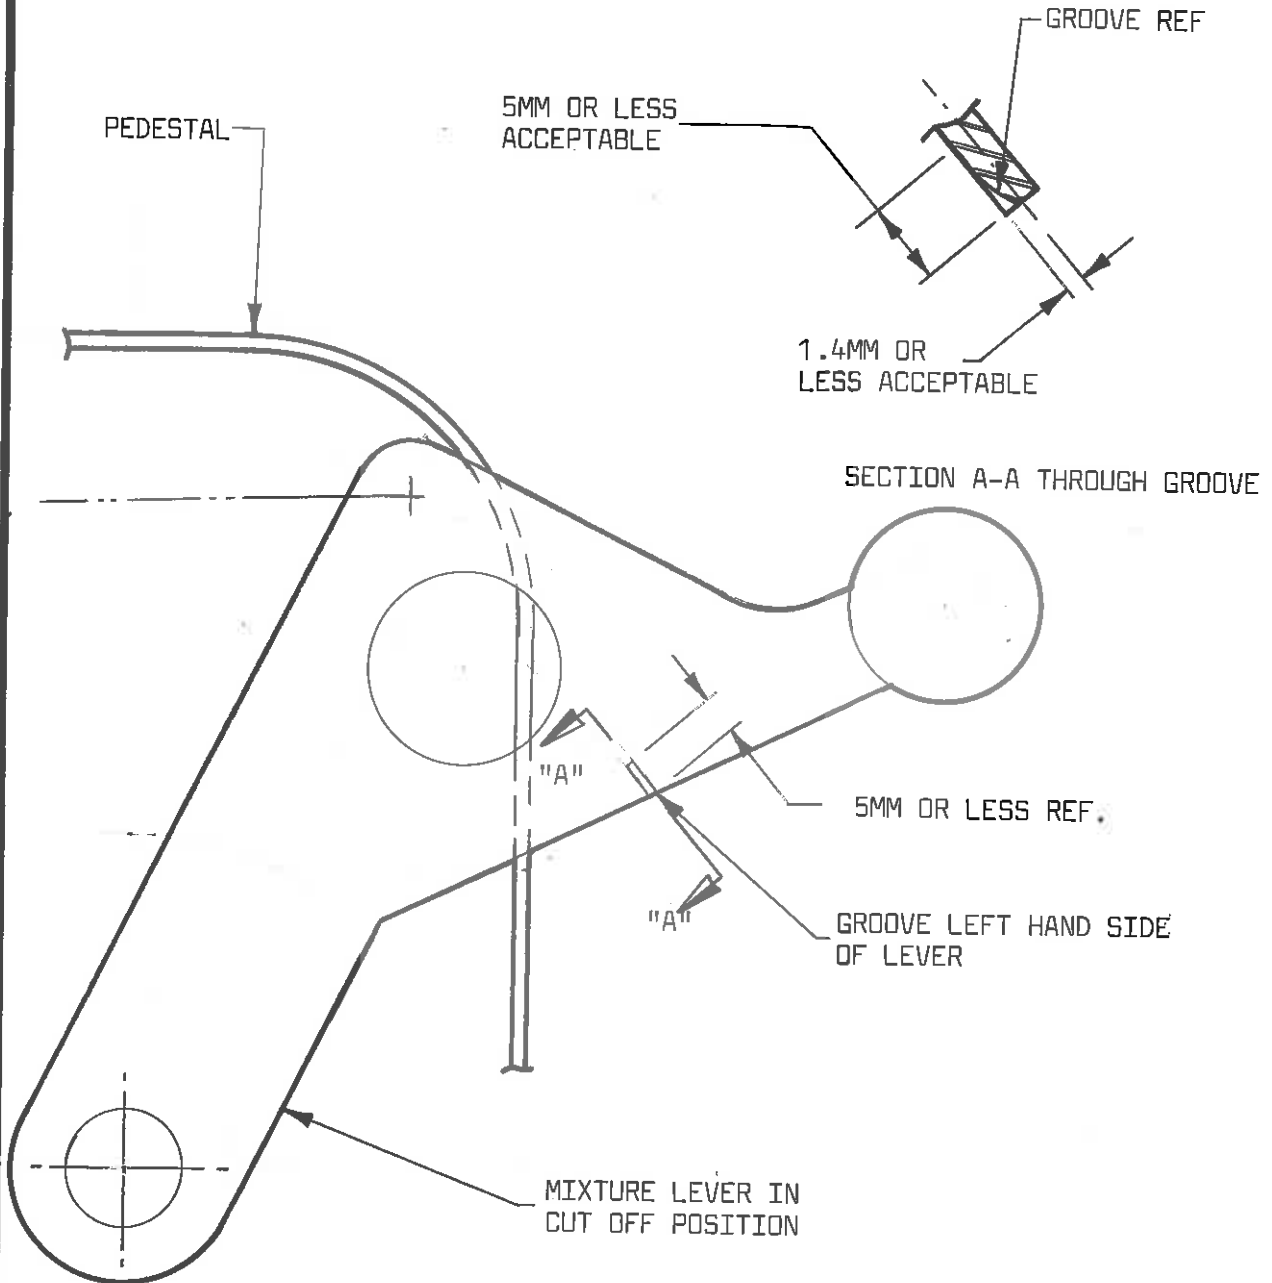
When operating the mixture lever from the full rich position to the lean position, it was noticed that mixture lever could be pulled past its gate toward the cut off position.

Upon investigation it was noted that the aluminium alloy mixture lever had a groove worn into it, having been caused by the pedestal gate.

FIG 1
SHOWING POSITION OF GROOVE

1. Visually inspect mixture lever for a groove. Ref Fig 1 for position.
2.
 - i) If a groove is absent, monitor every 50 flying hours with reference to Action 2ii).
 - ii) If there is a groove and it is 5mm or less in length, on the side of the lever and/or the groove is to a depth of half thickness of the lever (1.4mm) or less - ref Fig. 1, Section A-A - the lever is to be changed at next 150 flying hours, either with a new existing aluminium lever T67G-50-553 or Mod M722, steel lever, to be invoked.

- iii) If there is a groove and its length is greater than 5mm and/or its depth is greater than half the levers width, then lever is to be changed at next 50 flying hours, either with a new existing aluminium lever T67G-50-553 or Mod M722, steel lever, to be invoked.

If new aluminium lever T67G-50-553 is fitted, then re-inspect at next 150 flying hours, ref actions 2 i) and ii).
