**SERVICE BULLETIN**

SB No. 113 Issue No. 1

**TITLE**
**INSPECTION OF SAB NOSE LEG SCISSOR PIVOT**
**CLASSIFICATION**

T67B, T67C Pre Mod M468, T67M, T67M-MkII (Pre Mod M468) and T67M200

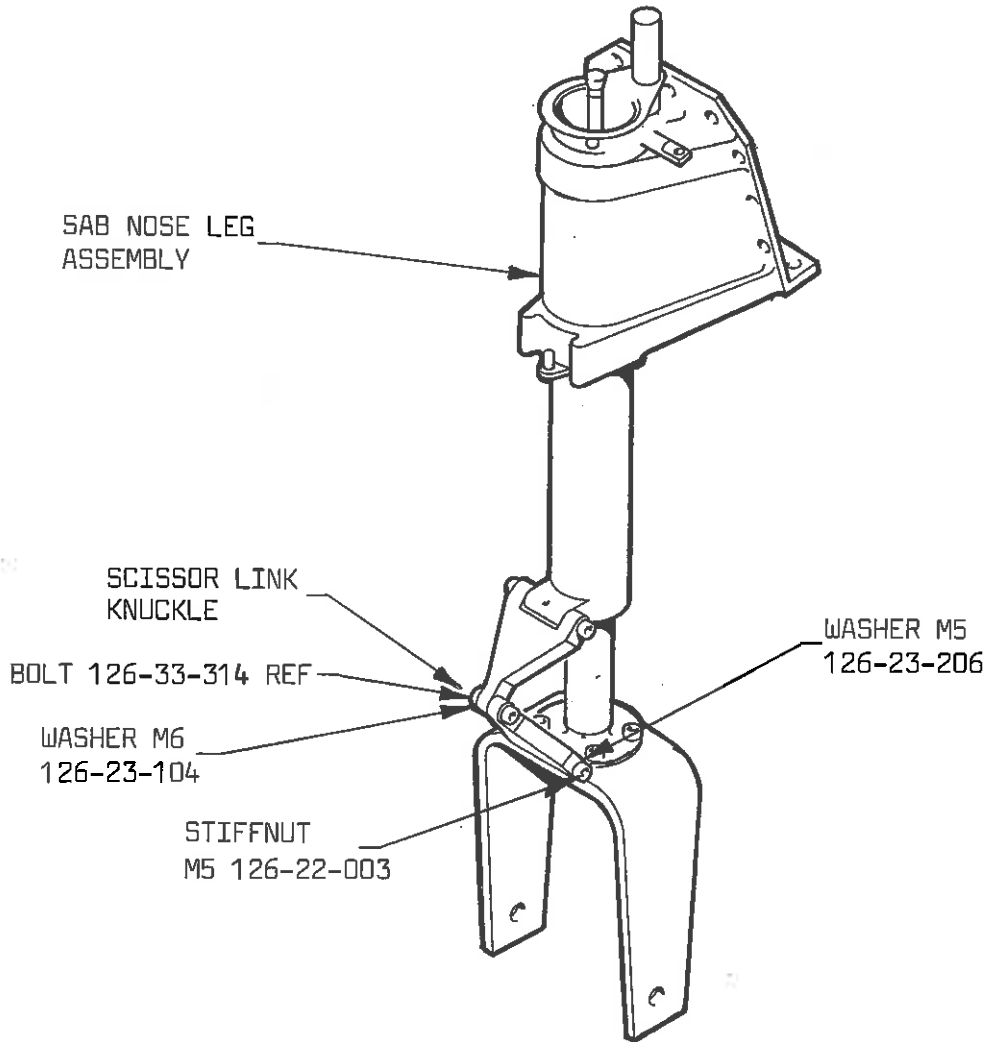
FIG 1  
SAB NOSELEG ASSEMBLY

A case has been reported of a loose stiffnut on the nose undercarriage scissor link knuckle joint.

An incorrect type of nut is specified in the IPC for the replacement. Additionally Part Numbers for washers were not specified.

1. Inspect for effective locking feature on stiffnut 126-22-003 ref Fig. 1. Effectivity can be established by simply trying to thread stiffnut down bolt by hand. If stiffnut can be threaded its full length, then stiffnut is to be replaced by new item.
2. Ensure stiffnut is torqued to 8.6NM (76 lbin).
3. Annotate IPC as follows:

Add 126-22-003 M5 Stiffnut in lieu of 126-35-244; 1 off M6 washer 126-23-104 and 1 off M5 washer 126-23-206 in lieu of washer 2 off (IPC Index No. 30, Chap 20, Page 7). IPC Fig 2 to be amended as annotations on SB Fig. 1.
4. Annotate airframe logbook "SB113 complied with".
