**SERVICE BULLETIN**

INSPECTION OF KING KT76A TRANSPONDERS

# ***BENDIX/KING® Service Bulletin***

**BULLETIN NO:** SB KT 76A-7  
KT 76A ATC Transponder

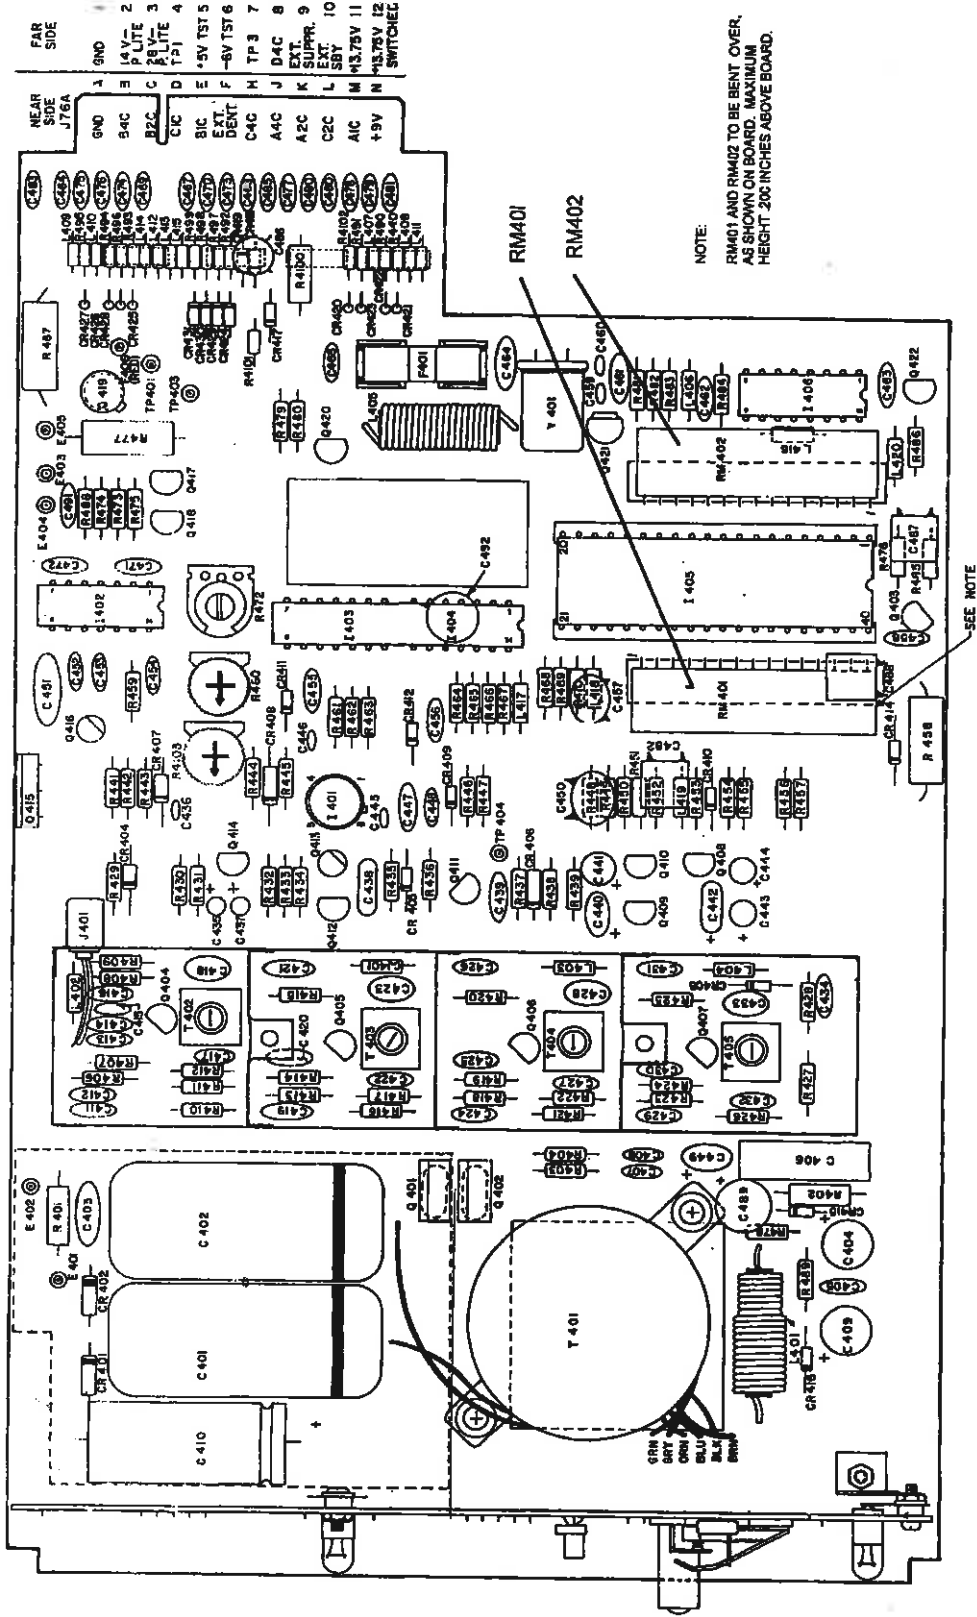
Figure 1  
KT 76A Main Board  
300-05824-0040 Rev-8

Silver migration on the substrate of a resistor network causes two problems. 1. The phenomenon creates low impedance paths between adjacent resistors in the network, causing the unit to incorrectly interpret the output of the encoding altimeter. 2. This condition can also cause the unit to transmit a code other than what is set in the transponder.

This modification consists of replacing two resistor network modules, RM401 and RM402, with new glass-coated parts.

1. Remove main board cover, and access the main board per the disassembly procedure contained in 5.3.4 of the maintenance manual.
2. Remove and discard old RM401 and RM402 from the main board.
3. Install new RM401 and RM402, P/N 015-00045-001, in the locations of the original parts.
4. Reassemble unit and reinstall covers.
