**SERVICE BULLETIN**

SB No. 119 Issue No. 1

TITLE LYCOMING S.B. NO.525A
INSPECTION OF HIGH PRESSURE FUEL PUMP P/N LW-15473**CLASSIFICATION**

SUBJECT: Inspection of High Pressure Fuel Pump P/N LW-15473

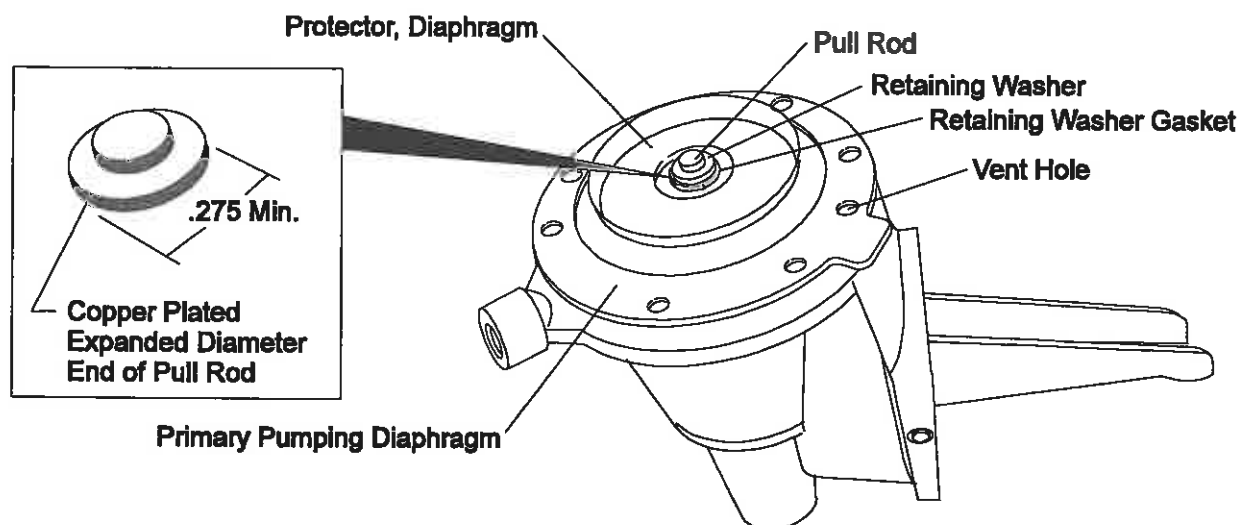
Figure 2.

Textron Lycoming has determined that a number of high pressure fuel pumps, P/N LW-15473, manufactured between June and October of 1995 may have manufacturing defects that may result in engine stoppage. Several instances have occurred where the retaining washer gasket has separated from the pull rod assembly and lodged in the pump outlet valve restricting fuel flow.

4. Visually inspect for proper location and retention of the retaining washer gasket in the pull rod/diaphragm assembly. (Refer to Figure 2.) If the gasket is not found between the retaining washer and diaphragm protector or it protrudes more than 1/16 inch beyond the retaining washer at any point, the pump is unserviceable and must be replaced.

5. Using vernier or dial calipers, measure the diameter of the larger copper plated expanded end of the pull rod immediately next to the retaining washer (see Figure 2). If this diameter measures less than .275 inches, the pump is unserviceable and must be replaced.
