SERVICE BULLETIN

SB No. 125 Issue No. 1

TITLE INSPECTION OF WIRING LOOMS AT REAR OF INSTRUMENT PANEL FOR CHAFING

T67A, T67B, T67C Series, T67M, T67M-MkII, T67M200, T67M260 and T67M260-T3A

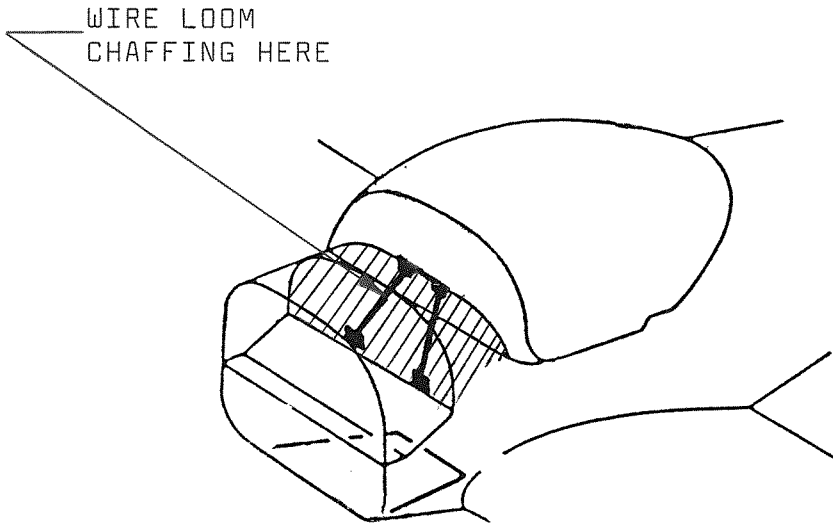
Cases have been reported of wiring looms to the rear of the Comm/Nav panel, chafing to the point of bare wires shorting on the strut preform support Part No. T67G-10-553, on the T67M260-T3A.

FIG 1
AREA OF POSSIBLE CHAFFING

1. Gain access to the rear of the instrument panel.
2. Inspect looms for signs of chafing or the possibility of chafing on any equipment racks, support struts or edges.
3. (i) Any wires found damaged beyond the outer jacket should be replaced or repaired as necessary. Ensure loom is repositioned to minimise chafing.
 (ii) A loom identified as in danger of chafing should be repositioned, secured and protected with spiral wrap or other anti-chafing material.
4. Maintenance Manual will add wiring/loom checks with regard to inspection for chafing at next amendment.
5. Annotate Logbook "SB 125 complied with".
