Service Bulletin

S.B. No: 130

Title: INSPECTION OF RUDDER PEDALS FOR ADJUSTMENT RESTRICTION

Applicability: T67B, T67C Series, T67M (excluding Works No. 1999), T67M-MkII, T67M200, T67M260 & T67M260-T3A

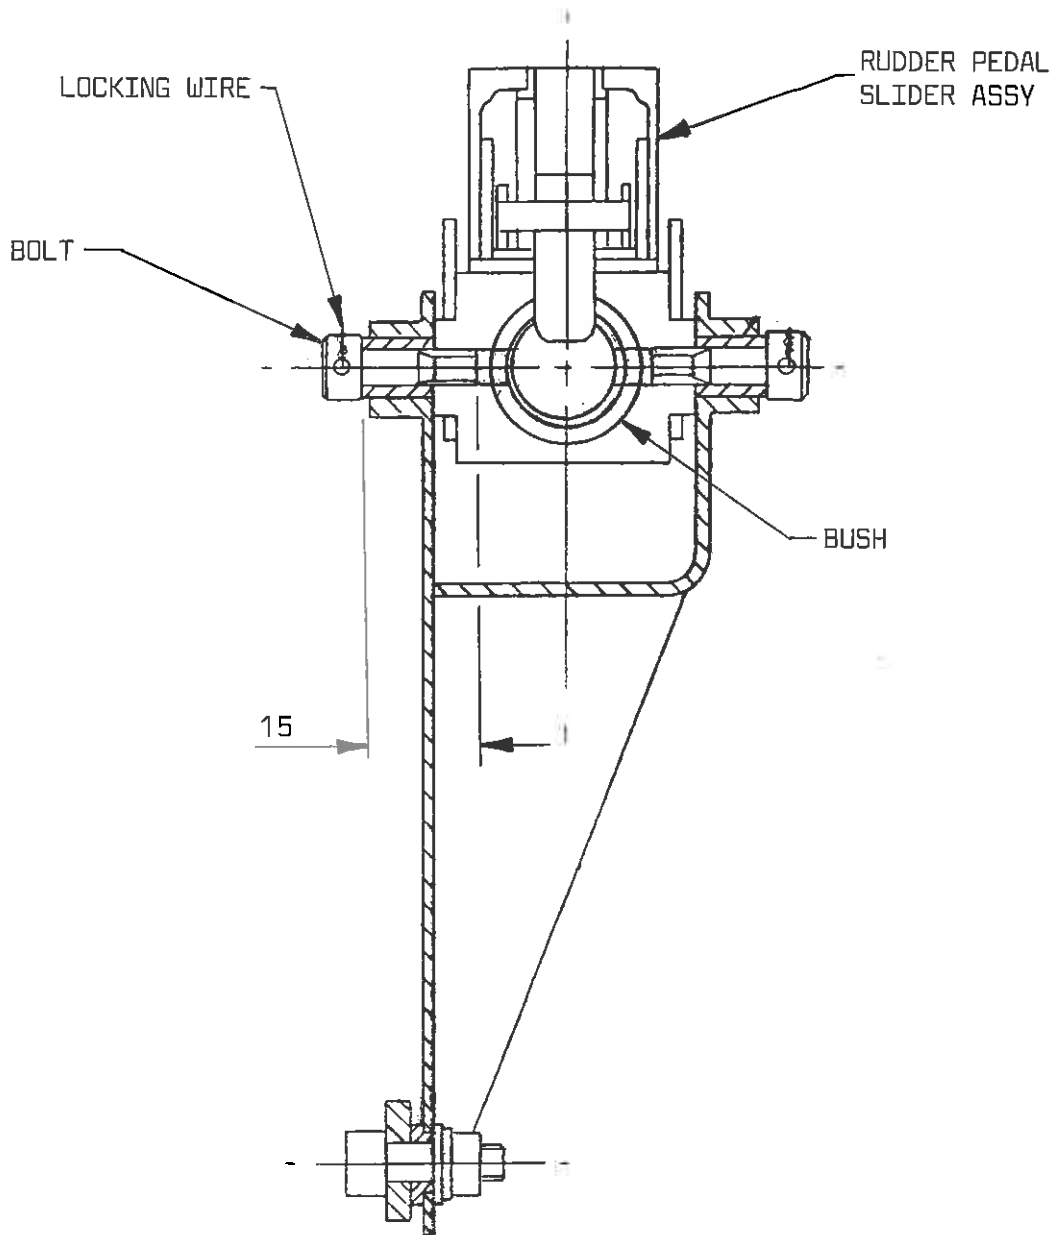
Fig 1
VIEW ON RUDDER PEDAL SLIDER HOUSING

A case has been reported of the pivot bolt fouling the rudder pedal slider assembly, preventing proper adjustment.

1. Inspect the rudder pedal assembly and check for full, free and smooth movement of adjustment slider.
2. If slider movement is restricted or appears stiff, inspect slider bush and pivot bolts for any visual signs of fouling, ref. Fig. 1.
3. If fouling occurs, adopt the following procedure:
 - i) Remove bolt or bolts that are fouling and shorten them by 1mm to give a nominal length of 15mm measured from the underside of the bolt head. Etch prime the cut face of the bolt. Re-identify bolt in IPC as T67B-08-537.
 - ii) Ream out internal diameter of bush to 16.00 +.05/-0 mm to remove any deformation caused by fouling.
 - iii) Replace shortened bolt T67B-08-537 and renew locking wire.
4. Alternatively, invoke Mod M808 to replace all pivot bolts.
5. Annotate logbook "SB 130 complied with".
