SERVICE BULLETIN

SB No. 147 Issue No. 1

TITLE SAB UNDERCARRIAGE NOSEWHEEL STEERING ADAPTOR INSPECTION

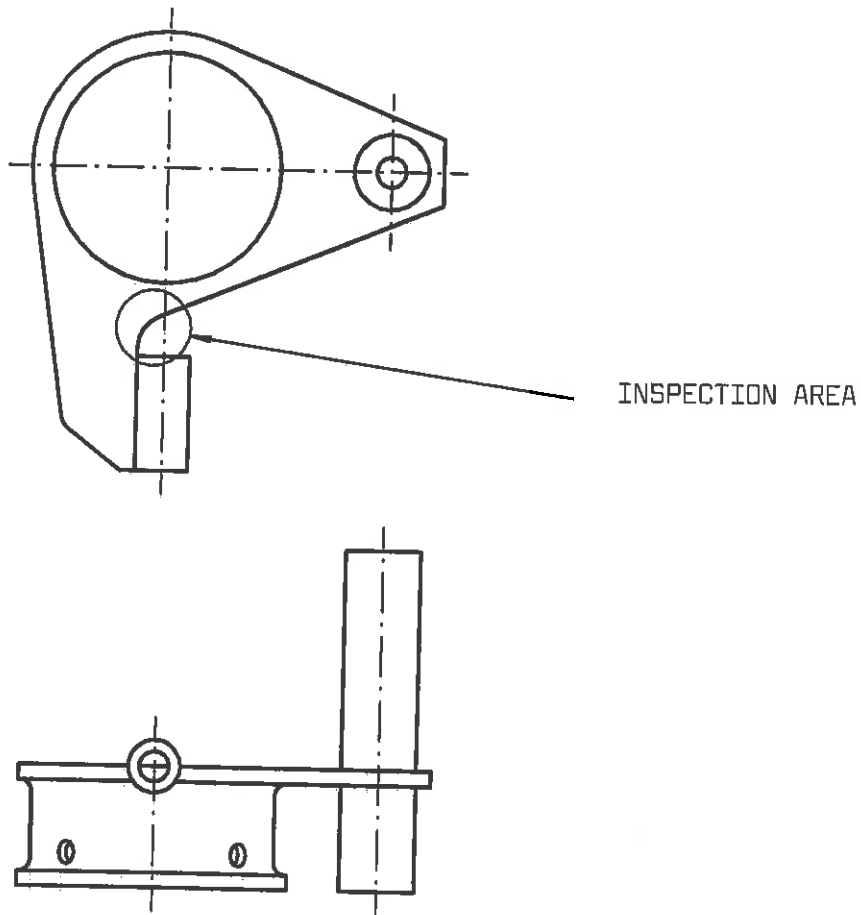
FIG 1 - SAB NOSEWHEEL STEERING ADAPTOR
(SAB PT. NO. 918-607)

A case has been reported of cracking in the nosewheel steering adaptor arm of aircraft fitted with SAB undercarriage. The origin of the crack was found to be impact damage, possibly sustained during refitting. This Service Bulletin requires an inspection of the adaptor and if necessary, repair.

3. Using strong light, magnification and a dye penetrant, visually inspect the steering adaptor, particularly the machined fillet and welded regions, as shown in Fig. 1, for cracking or impact damage.

4.
 - i. If no cracks are found, carefully smooth out rough finish if existent, restore finish and refit steering adaptor in accordance with Maintenance Manual. Annotate Logbook "SB 147 complied with".

- ii. If cracks up to but not exceeding 0.5mm in length are found, carefully blend out cracks and smooth rough finish if existent, restore finish and refit steering adaptor in accordance with Maintenance Manual. Repeat inspection every 50 flying hours or repair i.a.w. iii) below. Annotate Logbook after each inspection: SB147 complied with (50 hr inspection).

- iii. Cracks of lengths between 0.5mm up to and including 1.5mm may be repaired by cutting back to good material (use 'V' cut) and restoring original edge profile by welding as follows. Preheat area to 150°C prior to welding and stress relieve afterwards as follow. Allow weld to return to 150°C and then heat to 600°C ±25°C (dark brown/red in colour. Hold at 600°C for 10 minutes and allow to air cool to ambient temperature. Smooth rough finish if existent, restore finish and refit carefully in accordance with Maintenance Manual. Inspect after 10 hours to ensure integrity of repair. Annotate Logbook SB147 complied with. Repair to be performed by Approved Aircraft Welder.

- iv. If cracks greater than 1.5mm in length are found, return steering adaptor to Slingsby Aviation, cross referenced with aircraft serial number for assessment and repair or replacement. Fit repaired or replacement carefully in accordance with Maintenance Manual. Annotate Logbook "SB147 complied with".
5. Maintenance Manual to be annotated to include warning on care when refitting steering adaptor at next amendment, and visual inspection required at each 150 flying hour check.
