**SERVICE BULLETIN**

SB No. 150 Issue No. 1

TITLE INSPECTION OF ELEVATOR LEVER PIVOT STIFFNUT AT FRAME 7

APPLICABILITY:T67A, T67B, T67C Series, T67M, T67M-MkII, T67M200, T67M260
and T67M260-T3A**INTRODUCTION**

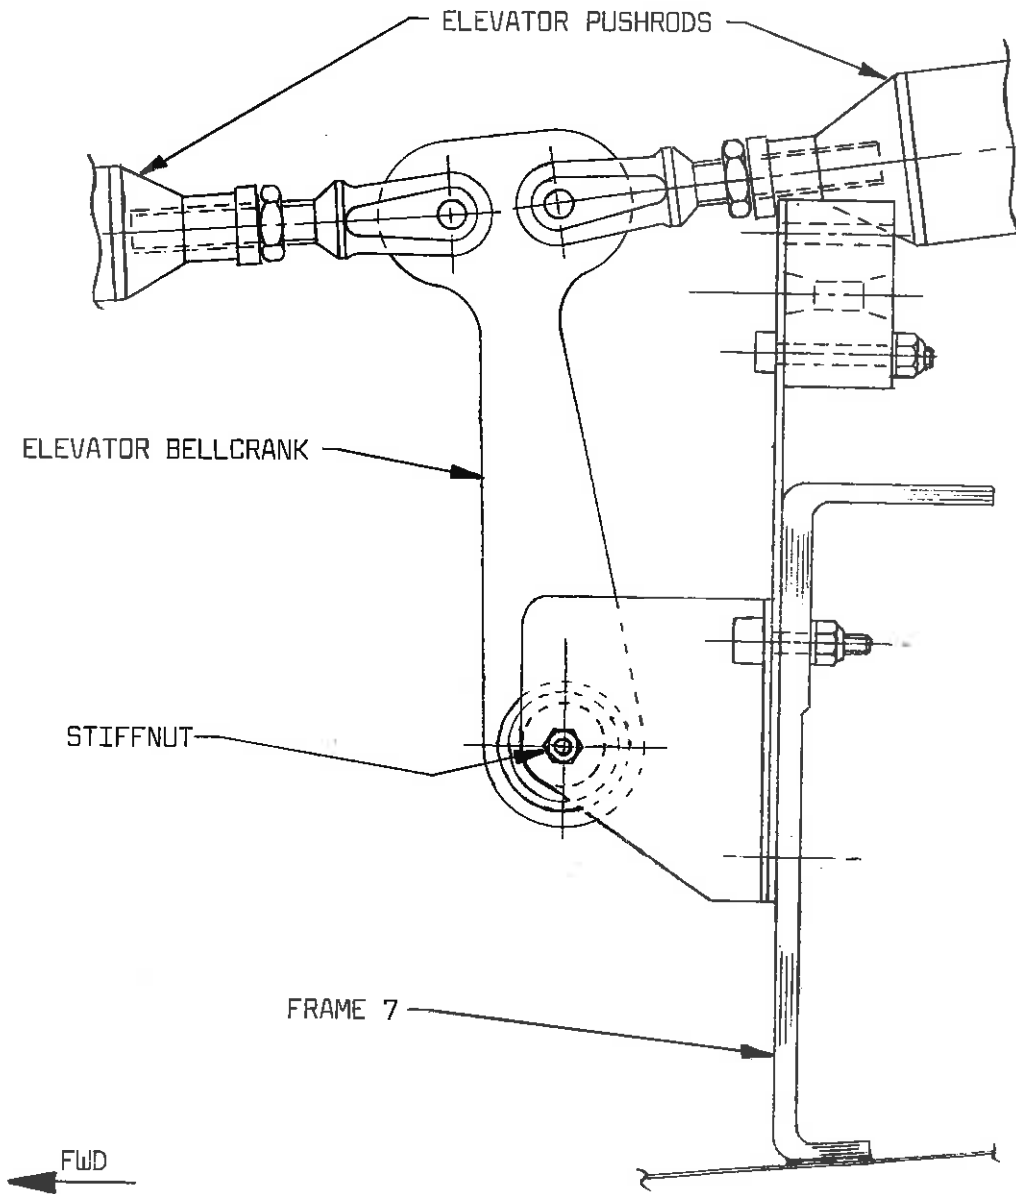
FIG 1
LOCATION OF STIFFNUT

Cases have been reported of the elevator bellcrank pivot stiffnut backing off. The bellcrank is mounted on Frame 7.

1. Gain access to rear of fuselage iaw relevant Maintenance Manual.
2. Inspect the pivot stiffnut ref Fig. 1 for signs of backing off.
3. If in doubt replace stiffnut.
4. Repeat paragraphs 2 & 3 at every 150 hours.
5. Annotate Log Book at every inspection "SB 150 carried out".
6. A Mod, M783, The Fitting of Slotted Nut and Split Pin in Lieu of Stiffnut, will be issued and on incorporation will supersede the requirements of this SB 150.
