Service Bulletin

S.B. No: 160

Title: INSPECTION OF LOWER UNDERCARRIAGE MOUNTING BLOCKS FOR WATER INGRESS.

Applicability: T67B, T67C, T67M, T67M-MkII, T67M200

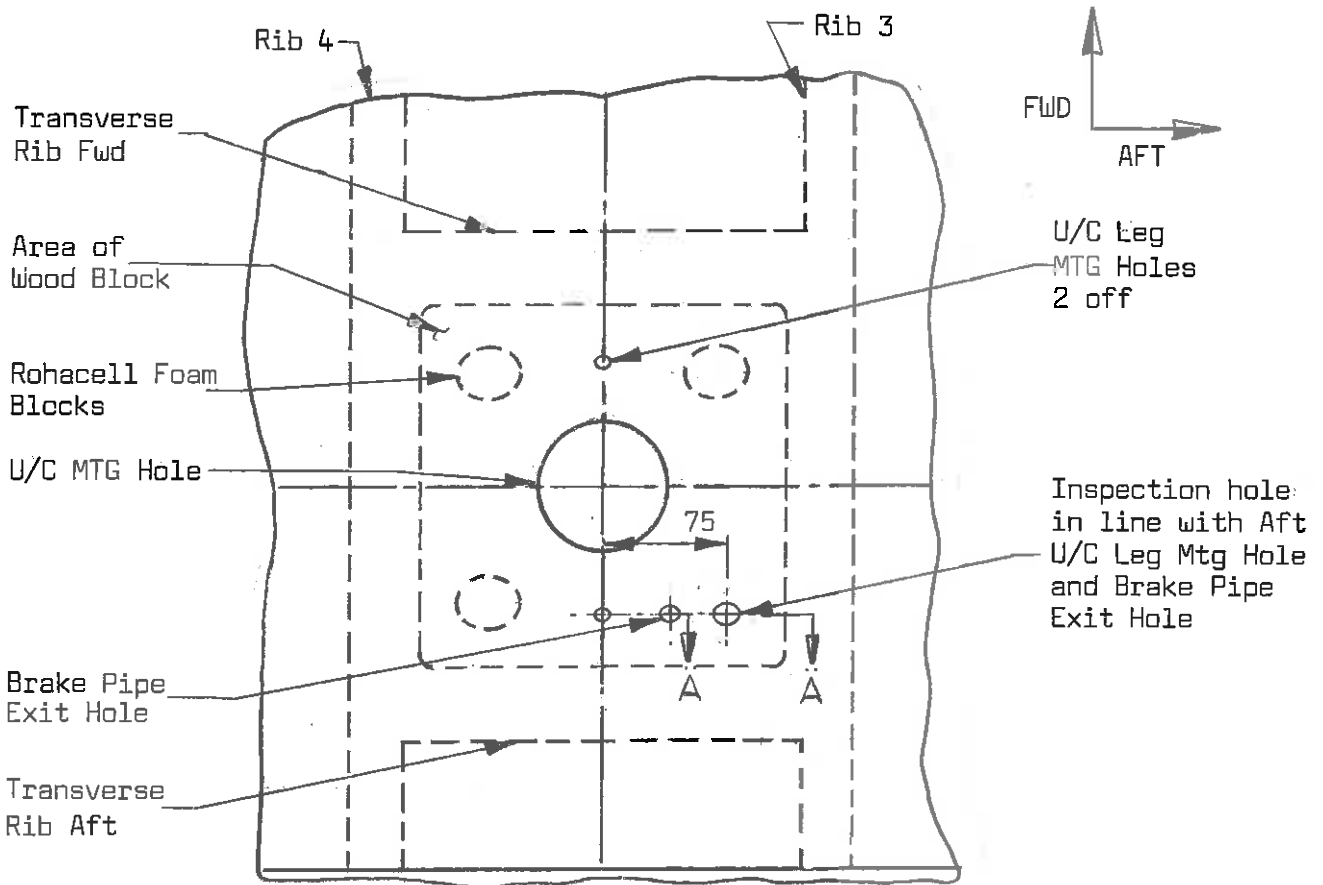
FIG 1

Should there be any doubt as to the integrity of the wooden mounting block, carefully drill a 12mm (½") diameter hole, to a maximum depth of 17mm, in the position shown on Fig 1, using a hand operated wood twist drill. Inspect removed material for high moisture content or rot.
