Service Bulletin

S.B. No: 161

Title: FUEL TANK VENT PIPE CHECK

Applicability: T67C Post Mod M156, T67M-MkII, T67M200, T67M260 and T67M260-T3A

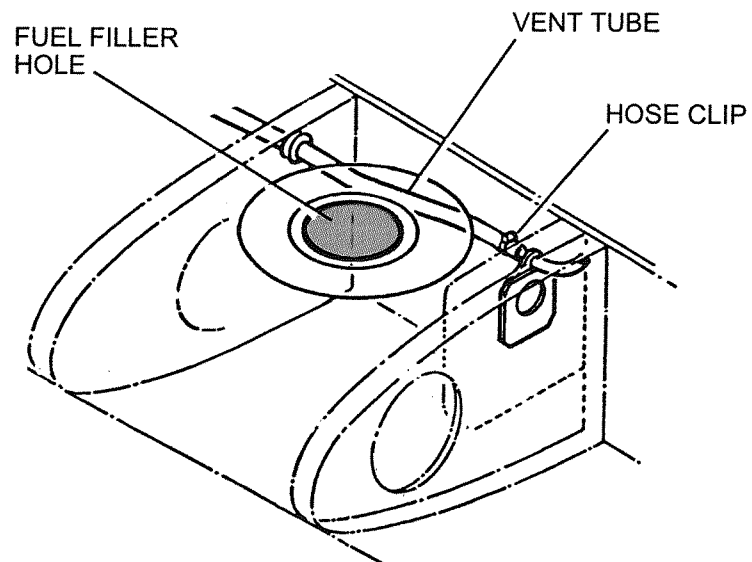
FIG. 1 WING TANK FUEL VENT PIPE

A case has been reported of the vent tube in the tank becoming detached from its fitting. The problem may have occurred during refuelling. A non-standard refuelling nozzle placed into the filler hole may catch the vent tube.

1. Remove fuel filler caps from both wing tanks, ensure safety precautions are observed.
2. Using a mirror and a torch (if required) observe fuel vent tube, ref Fig 1.
3. Check:
 - i) Correct routing of vent tube, ie straightness. If tube is slack ensure it cannot be fouled by refuelling nozzle.
 - ii) Vent tube hose clip is still in its correct position, tight and is correctly supporting the vent tube.
4.
 - i) Should inspection prove satisfactory annotate logbook "SB161 complied with."
 - ii) If requirements of paragraphs 3 i) and ii) cannot be satisfied then gain access to wing tank as per Maintenance Manual and rectify. Upon rectification annotate logbook "SB161 complied with."
