Service Bulletin

S.B. No: 162

Title: INSPECTION OF PITOT TUBE INLET PIPE AND LIGHTNING CONDUCTOR FOR CRACKING

Applicability: T67B, T67C Series, T67M, T67M-MkII, T67M200, T67M260 and T67M260-T3A

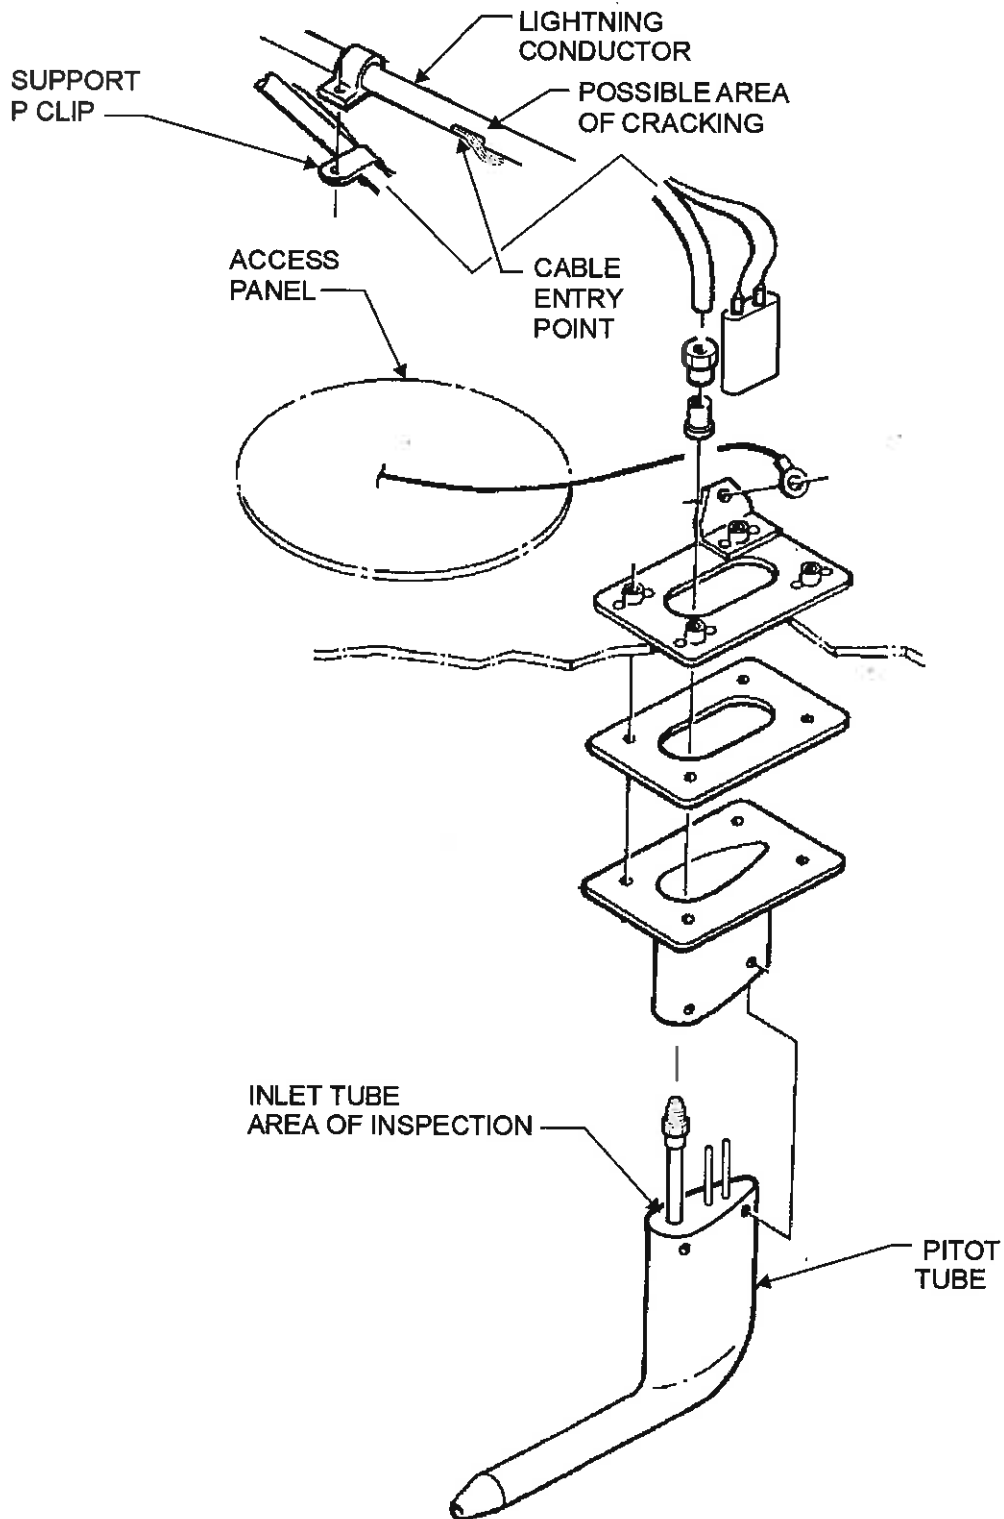
Figure 1 Pitot Tube Installation

A number of cases have been reported of the pitot tube inlet pipe cracking at its entry point to the pitot head, resulting in a loss of indicated air speed. This Service Bulletin requires an inspection and, if necessary, replacement of the pitot tube.

- iv. Remove the four crosshead screws holding the mounting bracket to the pitot head.
 - v. Carefully ease the pitot head out of the mounting bracket.
 - vi. Carefully remove the electrical connector.
3. Perform visual check for cracks in the inlet tube of the pitot in the area shown in Figure 1.
 4. Perform check port and starboard on lightning conductor for cracks.
 5. If no visual sign of cracking exists on the pitot, refit pitot tube. Re-fit in reverse order of removal, ref paragraph 2.

If no cracking exists in lightning conductor, continue as paragraph 9.
 6. If signs of cracking exist in the pitot head tube, replace with a new item. Re-fit in reverse order of removal, ref paragraph 2. For purchase, please contact SAL Product Support Department.
 7. If cracking exists in lightning conductor, repair in accordance with T67B-03-029.
 8. Ensure pipe is properly supported (ref P-clip, Figure 1), and care is to be taken that inlet pipe is not stressed during installation and future maintenance. Note to this effect will be added to Maintenance Manual together with removal and installation procedure.
 9. Replace access panels.
 10. Attach placard T67B-00-305 as indicated by Figure 2. Both port and starboard access holes.
 11. Annotate in aircraft logbook "SB 162 complied with, Mod M934A incorporated".

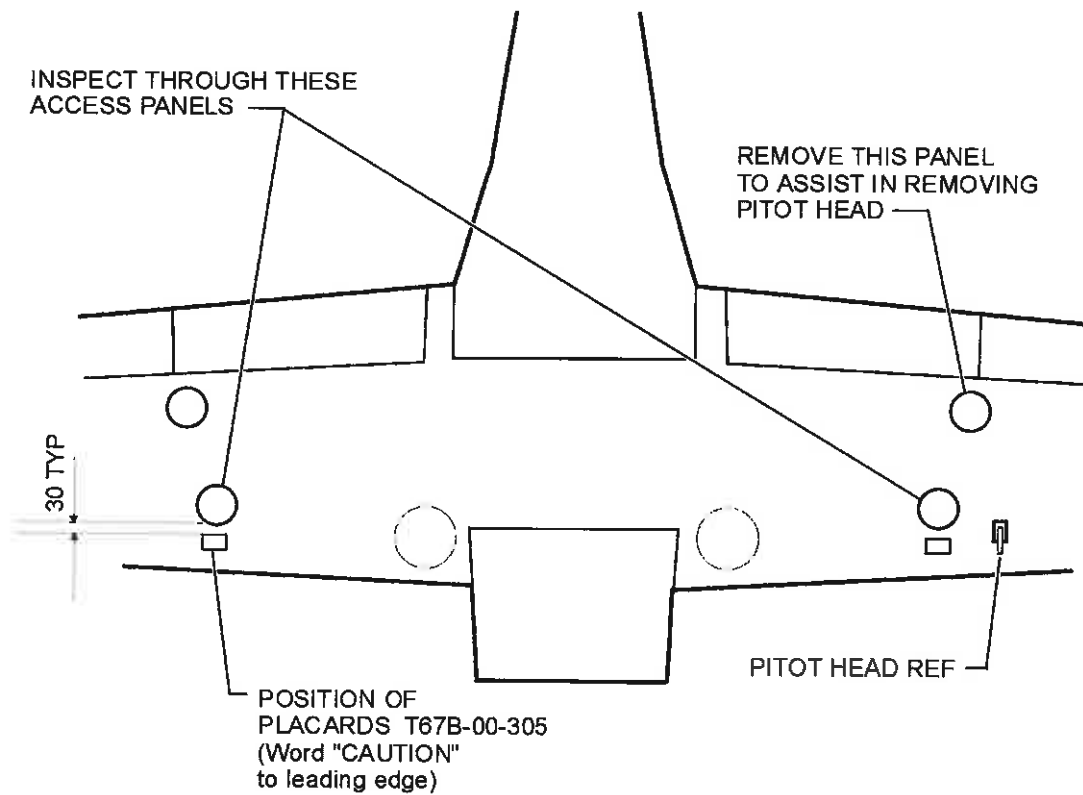
Figure 2 Showing Access Panels and Placard Position

Additionally, a case has been reported of cracked lightning conductor at the access holes indicated, ref Figure 2. An inspection is also required to check for any cracking in the lightning conductor and rectification as required.

1. Remove access panels indicated by Figure 2.
2. Carefully remove pitot tube from lower wing surface as follows:
 - i. Ensure that the master switch and heated pitot switch are both OFF.
 - ii. Remove two inspection panel covers, one next to the pitot head and one further aft near the flap centre bearing rib.
