# Service Bulletin

S.B. No: 167

**Title:** INSPECTION OF EXTERNAL AILERON AND FLAP DRIVE PUSHROD FOR CRACKING

**Applicability:** T67A, T67B, T67C, T67M, T67M-MkII, T67M200, T67M260 and T67M260-T3A.

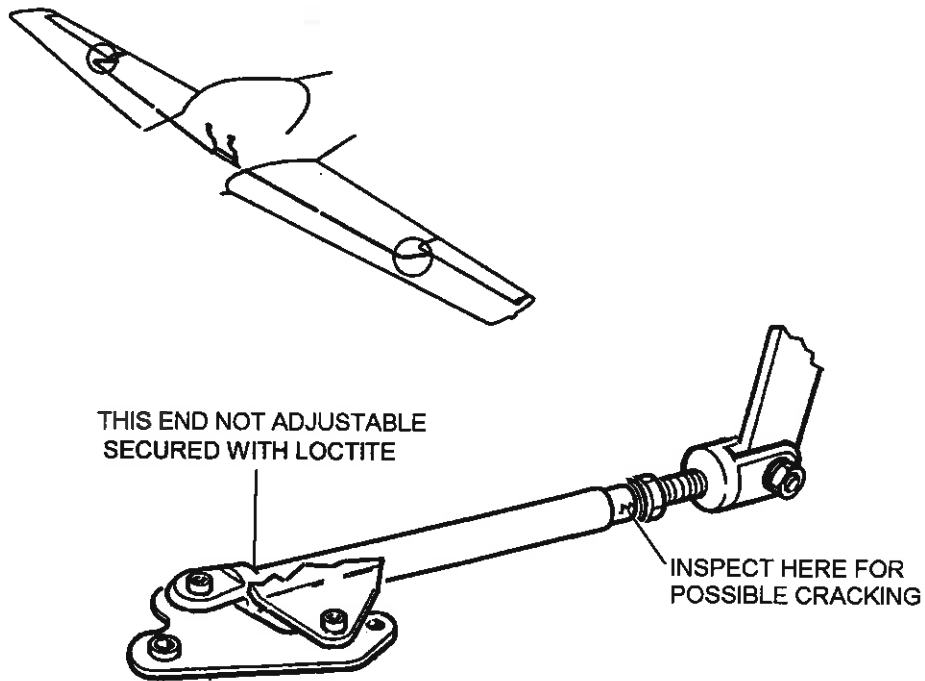
FIGURE 1

Cases have been reported of cracking having been found on both the aileron and flap external drive pushrods during normal maintenance.

The cracking is thought to have occurred during adjustment of the pushrods. The fork end has been difficult to move due to corrosion.

1. Check master switch, ignition switch and fuel are OFF. Disconnect external power and hangar aircraft, if required.
2. Inspect the pushrods at the extremes at the ends of the bodies: the cracks are usually on the spanner flats. Ref Fig. 1.
3. If cracking is present, replace pushrod with relevant item, ref IPC.
4. Maintenance personal to ensure:
  - i. When adjusting these pushrods, to inspect for cracks and replace pushrod if required.
  - ii. That the adjustable end is only used for adjustment, ref Fig 1. Note forward end is attached with Loctite and is not for adjustment.
5. Maintenance Manual to reflect 4 i. and ii. An Advance Information Leaflet will be issued.
6. Annotate logbook "SB 167 complied with."
