Service Bulletin

S.B. No: 170

Title: INSPECTION OF CONTROL COLUMN AILERON STOP BOLT, MOUNTING PLATE AND RIVNUT

Applicability: T67A, T67B, T67C, T67M, T67M-MkII, T67M200, T67M260 and T67M260-T3A

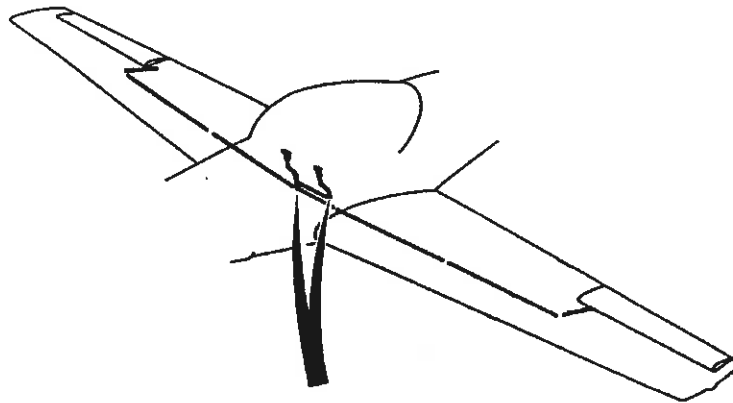
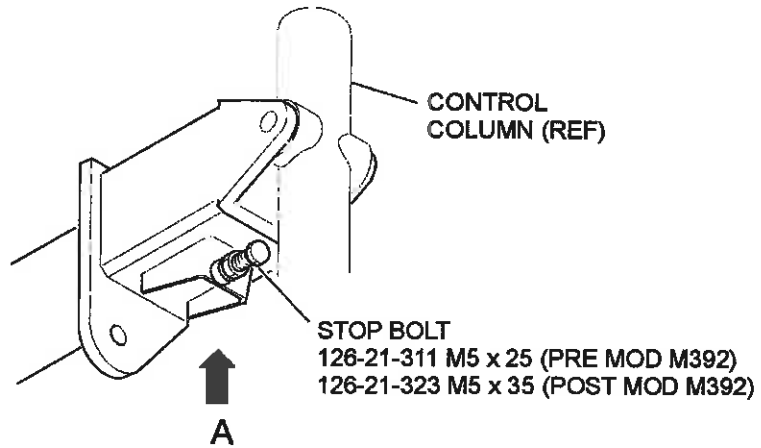
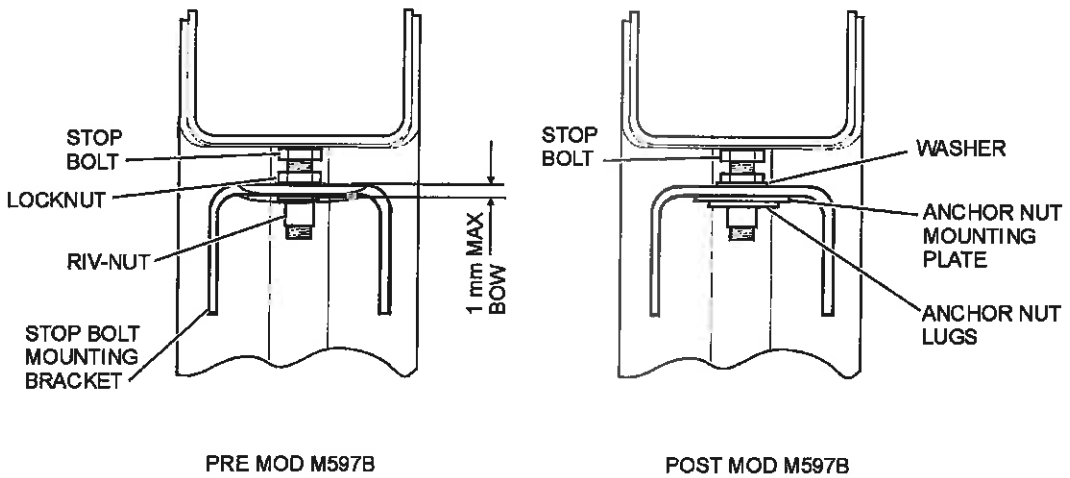
FIGURE 1

1. Check master switch, ignition switch and fuel are OFF. Disconnect external power and hangar aircraft if required.
2. Gain access to the base of the control column and to each aileron stop mounting position.
3. Inspect the stop bolt and its mounting for:
 - a, On Post Mod M392 aircraft: incorrect length of bolt. Bolt should measure, from under head, 35mm, (Pre Mod length is 25mm).
If bolt on a Post Mod M392 aircraft measures 25mm replace with bolt SAL stores code 126-21-323.
 - b. On Pre Mod M597B aircraft: i) bowing and ii) loose rivnut.
If mounting is bowed greater than 1mm – ref. Fig 1 Pre Mod M597B – and/or rivnut is loose. Invoke repair scheme to SAL DOI T67C-114 Post Mod M597A.
Post Mod M597B aircraft: i) loose locknut, ii) thin washer (.8mm thick) and iii) deformed or broken anchor nut lugs. See Figure 1 Post Mod M597B..

If loose locknut found, check washer is not bowed. If washer is bowed, replace with SAL Part No T67G-03-545.

If thin washer fitted replace with washer T67G-03-545.

If deformed or broken anchor nut lugs found then re-invoke repair T67C-114 issue 3 or subsequent.
