Service Bulletin

S.B. No: 172

Title: INSPECTION OF FLAP DRIVE TORQUE TUBE

Applicability: T67A, T67B, T67C, T67M, T67M-MkII, T67M200, T67M260 and T67M260-T3A

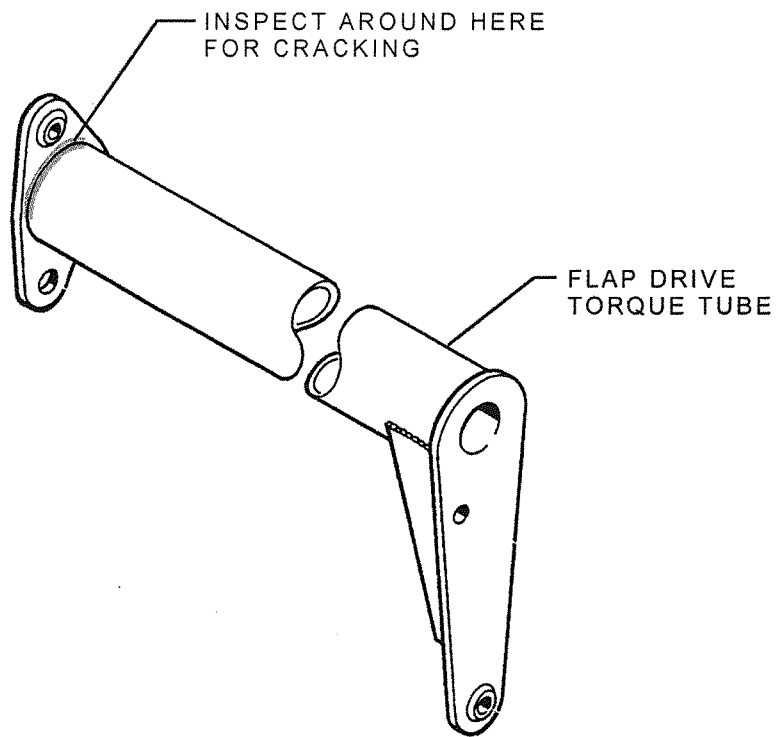
FIGURE 1

A case has been reported of a crack on the flap drive torque tube, pivot to tube brazed joint located at the inboard end of the torque tube.

1. Gain access to the inboard end of the flap drive torque tube.
2. Visually inspect for signs of cracking, i.e. flaked paint etc. in area indicated ref. Figure 1. If in doubt remove paint locally and use dye penetrant as required.
3. If no cracks are present, annotate logbook "SB172 complied with". Note if paint removed, clean and repaint.
4. If cracking is present inform Slingsby Aviation Limited and replace with new item. Annotate logbook "SB 172 complied with."
