S.B. No: 172

**Title:** INSPECTION OF FLAP DRIVE TORQUE TUBE

**Applicability:** T67A, T67B, T67C, T67M, T67M-MkII, T67M200, T67M260 (Pre Mod M950) and T67M260-T3A

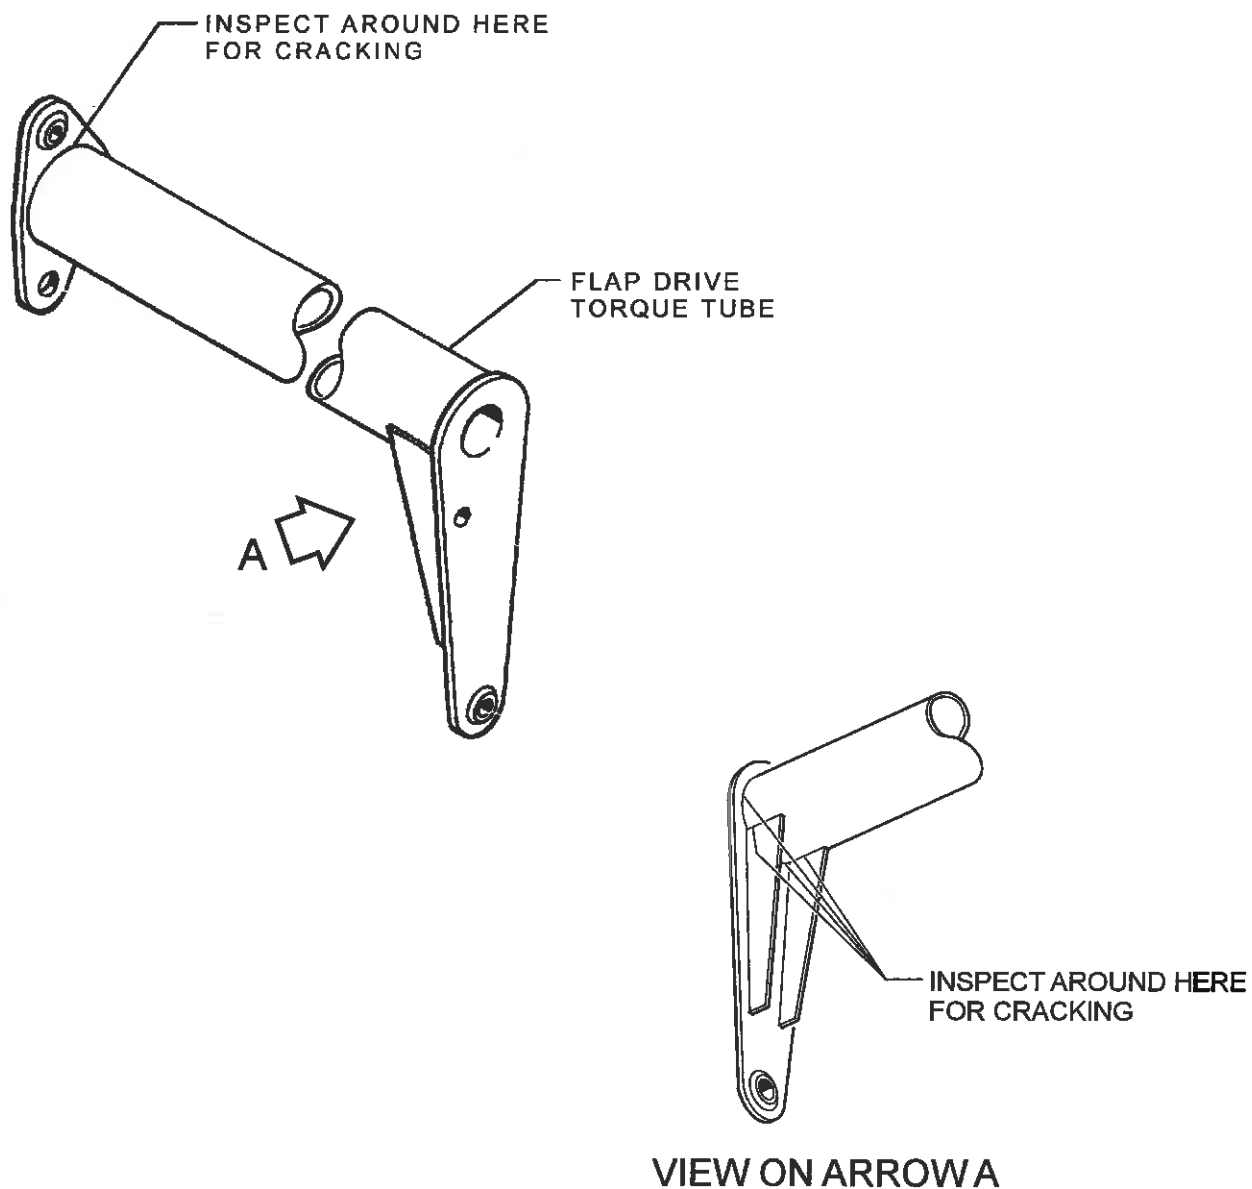
**FIGURE 1**

Cases have been reported of cracks at the inboard and outboard ends of the flap drive torque tube.

1. Gain access to the inboard and outboard ends of the flap drive torque tube.
2. Visually inspect for signs of cracking, i.e. flaked paint etc. in areas indicated ref. Figure 1. If in doubt remove paint locally and use dye penetrant as required.
3. If no cracks are present, annotate logbook "SB172 complied with". Note if paint removed, clean and repaint.
4. If cracking is present, obtain new welded item T67G-45-243/244 from Slingsby Aviation Limited. Annotate logbook "SB 172 complied with, Mod M948 invoked".
