# Service Bulletin

S.B. No: 180

**Title:** INSPECTION OF ALTERNATOR/STARTER WIRING LOOM P-CLIPPING AT ENGINE

**Applicability:** T67A, T67B, T67C, T67M, T67M-MkII, T67M200, T67M260 and T67M260-T3A

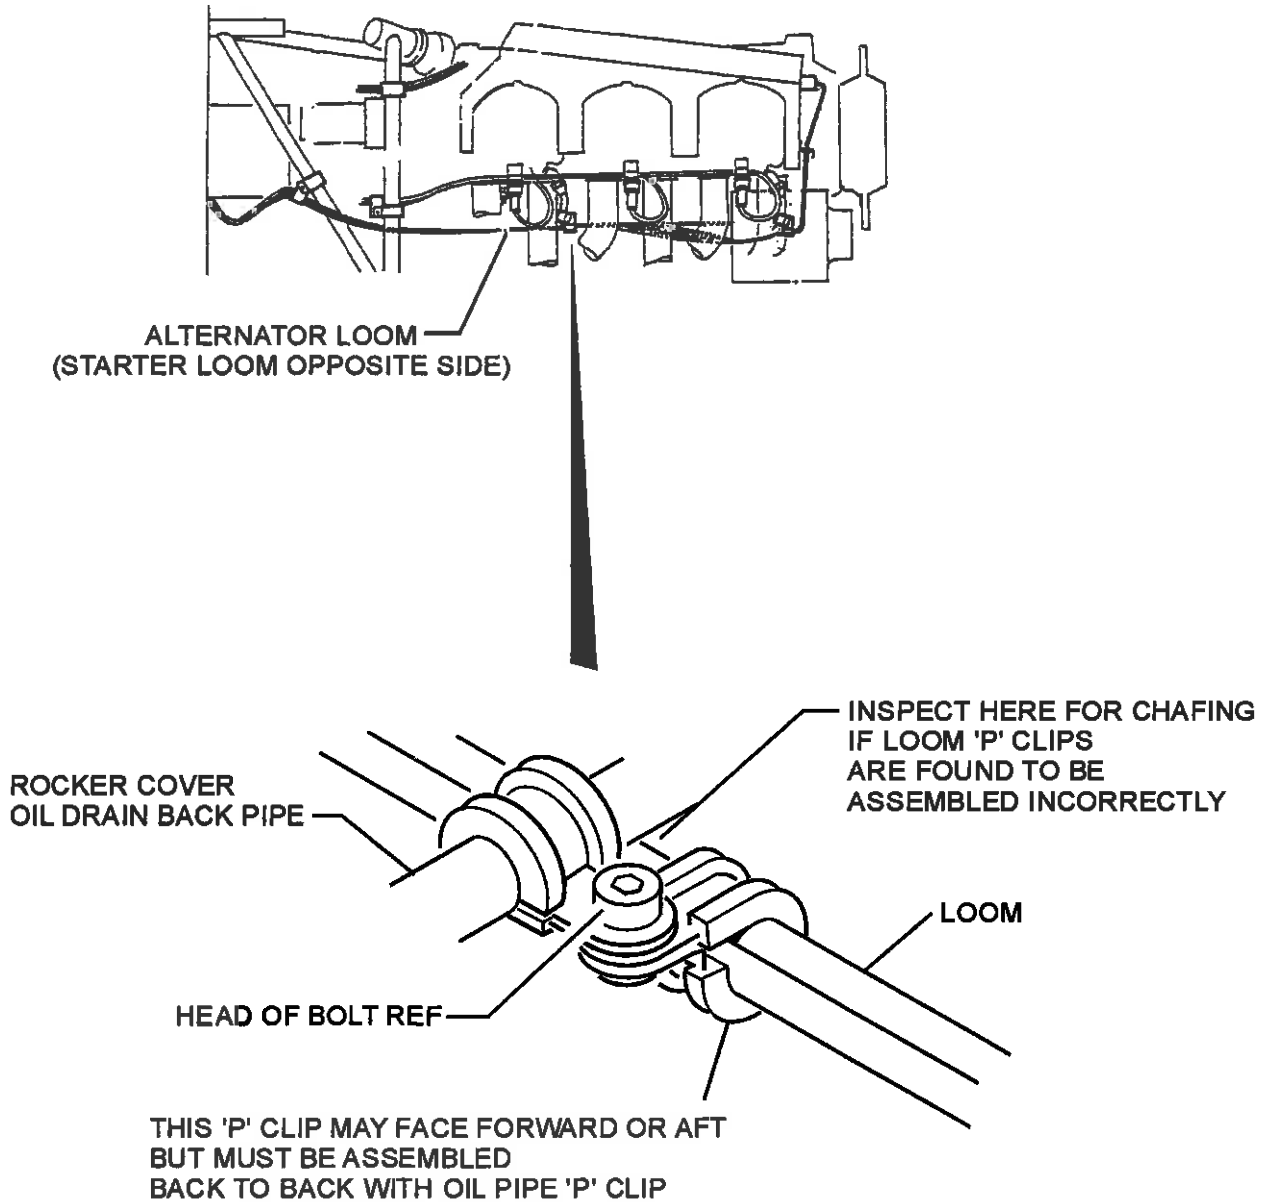
FIGURE 1

A case has been reported of the alternator wiring loom chafing against the rocker cover oil drain back pipe. On further investigation, it was found that the 'p' clip on the pipe had been fitted incorrectly, bringing the loom into contact with the pipe, which then chafed through the pipe causing oil to seep out.

1. Check master switch, ignition switch and fuel are OFF. Disconnect external power and hangar aircraft if required.
2. Gain access to the engine bay.
3. Inspect both the alternator wiring loom starboard side and starter loom port side of engine for correct 'p' clip assembly, ref. Figure 1. Ensure loom is positioned away from all engine components and structure.

T67M260 HP ENGINE SHOWN  
OTHER ENGINES SIMILAR

4. Should 'p' clip not be as Figure 1 then disassemble. Inspect oil drain back pipe for chaffing: if damaged replace pipe. Check looms for chafing. If looms lightly chafed, repair by re-insulating with heatshrinkable sleeving or similar permanent repair. If chafing is more severe and wire conductor is damaged, rectify by replacing affected wire.
5. Assemble 'p' clip and loom back to pipe as per Figure 1.
6. Annotate logbook "SB 180 complied with."
