Service Bulletin

S.B. No: 186

Title: INSPECTION OF RUDDER NAVIGATION LIGHT WIRING FOR CHAFFING

Applicability: T67B, T67C Series, T67M, T67M-MkII, T67M200, T67M200 (Post Mod M915), T67M260 and T67M260-T3A. Not applicable Post Mod M950 aircraft (Works Numbers 2266 to 2281 inclusive).

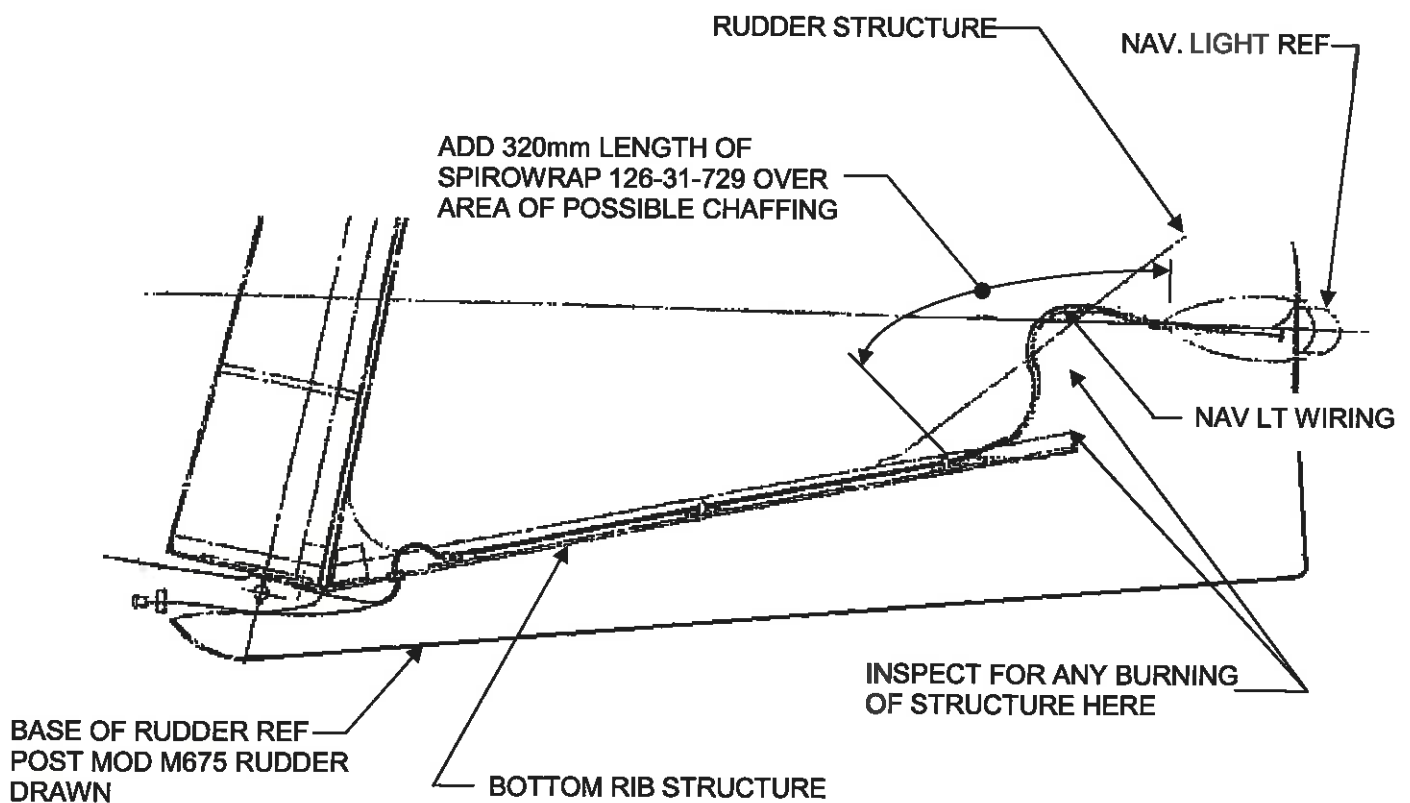
FIGURE 1

A case has been reported of chaffing of a rudder navigation light cable. The cable chaffed through causing the circuit breaker to operate. External inspection revealed evidence of burning on fabric. On removal of navigation light the cable was found to be broken and the lower rudder rib had been burnt which had caused the scorch marks on the outside of the rudder.

Further to issue 1 of this Service Bulletin SACL have found evidence of chaffing of navigation wiring on other Firefly types. Though in all cases the outer insulation has not been found to be completely removed. Therefore it is recommended that the following action is complied with.

- 1 Remove navigation light from rudder by releasing the 2 fixing screws and breaking sealant.
- 2 Carefully withdraw light from rudder.
- 3 Check wiring for any chaffing in area indicated by Figure 1.
- 4 Using a mirror and light check for any signs of rubbing on rudder structure.
- 5 If there is no cable damage then protect wiring as per Figure 1 with Spiral Binding 126-31-729.

- 6 If there is cable damage but no sign of burning, then cable is to be replaced and Change Mod M1025B "Introduction of Tail Navigation Light Wiring Protection Strip on Lower Rib Only and Re-routed Wiring" to be invoked.
- 7 If there is any sign of burning, Rudder to be returned to SACL for structural repair under Change Mod M1025A "Introduction of Repair to Burnt Rudder Includes Tail Navigation Light Wire Protection Strip on Lower Rib and Re-routed Wiring"
- 8 In any case Change Mod M1025B to be invoked at next fabric recovering. Repair Manual to be amended to include wiring condition check and rectification at next amendment.
- 9 Annotate aircraft log book SB 186 complied with.
