Service Bulletin

S.B. No: 191

Title: INSPECTION OF INTEGRITY OF FRAME 6 AND 7 JOINT BONDING

Applicability: T67B, T67C Series, T67M, T67M-MkII, T67M200 and T67M260.

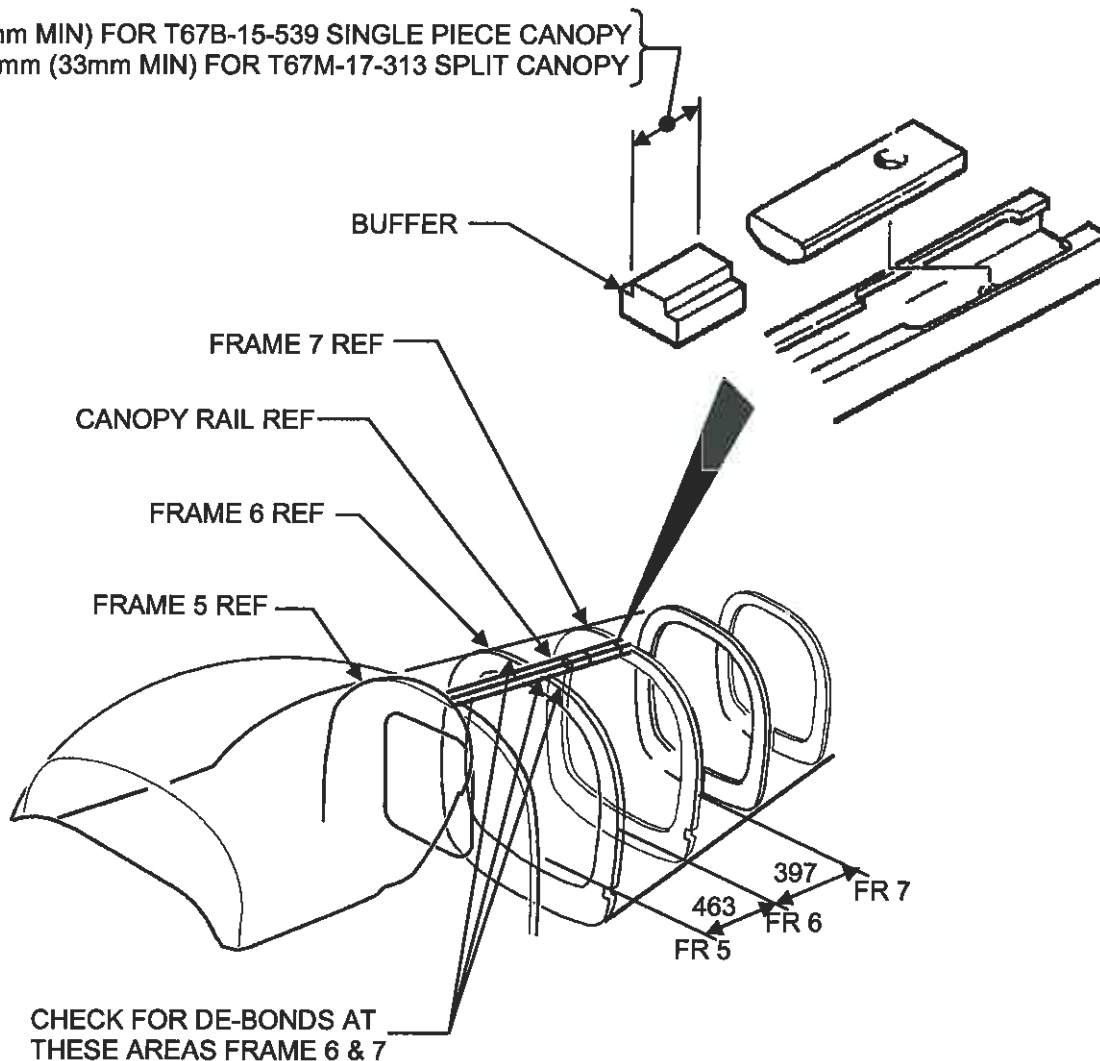
FIGURE 1
INDICATING POINTS OF INSPECTION OF BUFFER & FRAMES

During the annual inspection a maintenance organisation reported de-bonding of Frame 6 and Frame 7 from the aircrafts skin over local areas adjacent to the canopy slide rails. Investigation revealed that the de-bonds were clean and had not damaged skin or frame structure.

Past records have shown this type of damage can be caused by the canopy being allowed to "slam" back during opening. Additionally if the canopy slide rail buffer is missing then this can cause similar damage. Operators are advised that all persons working around the aircraft follow the canopy opening guidelines in the Pilot Notes.

- 1 Check canopy slide rail for canopy buffer, reference Figure 1. Check length of buffer, for single piece canopies length should be 50mm and for split canopy length should be 35mm +1/-0mm. If buffer is missing or lengths measure less than 2mm than stated at Figure 1, then replace with T67B-15-539 for single piece canopy; or T67M-17-313 (issue 3 & subs.) for split canopy.
- 2 Place trestle under bump stop of aircraft.
- 3 Gain access to aft fuselage via Frame 5 access panel and position crawl boards into aft fuselage. These are available from MSAC (Marshall Slingsby); order part numbers T67G-88-025 port and T67G-88-026 stbd. Ensure no damage to controls, structure, cable, etc. whilst positioning boards and during course of any work there in.
- 4 Inspect bond of Frames 6 and 7 to top skin either side of canopy rail GRP preform and to the preform.

50mm (48mm MIN) FOR T67B-15-539 SINGLE PIECE CANOPY
35mm +1/0mm (33mm MIN) FOR T67M-17-313 SPLIT CANOPY

- 6 If a de-bond is detected, assess as to whether the joint line (bond area) is clean (smooth) or delaminated skin or frame. Only if bond area is clean, proceed as per step 7. If bond area is not clean, obtain advice from MSAC before proceeding.

- 9 Gently abrade area/s of de-bond. If this action extends the de-bonded area, continue until bond holds firmly. It is recommended to use 80 grit emery cloth, followed by cleaning with Acetone, Methyl Ethyl Ketone (MEK) or local equivalent.

- 10 Referring to the T67 GRP Repair Manual (4th Edition) mix a quantity of adhesive 126-51-042 and inject with syringe into joint ensuring that the adhesive fills entire de-bonded area. Starting at the front, proceed to the rear maintaining a consistent quantity of squeeze out down the length. Gather and wipe away any squeeze out.

- 11 Post-cure the bond in accordance with the T67 GRP Repair Manual (4th Edition) paragraph 2.6 step (8), taking suitable precautions to ensure no damage to the existing structure.
