Service Bulletin

S.B. No: 192

Title: INSPECTION FOR INTEGRITY BONDING OF THE JACKING POINT

Applicability: T67A, T67B, T67C series, T67M, T67M-MkII, T67M200 and T67M260.

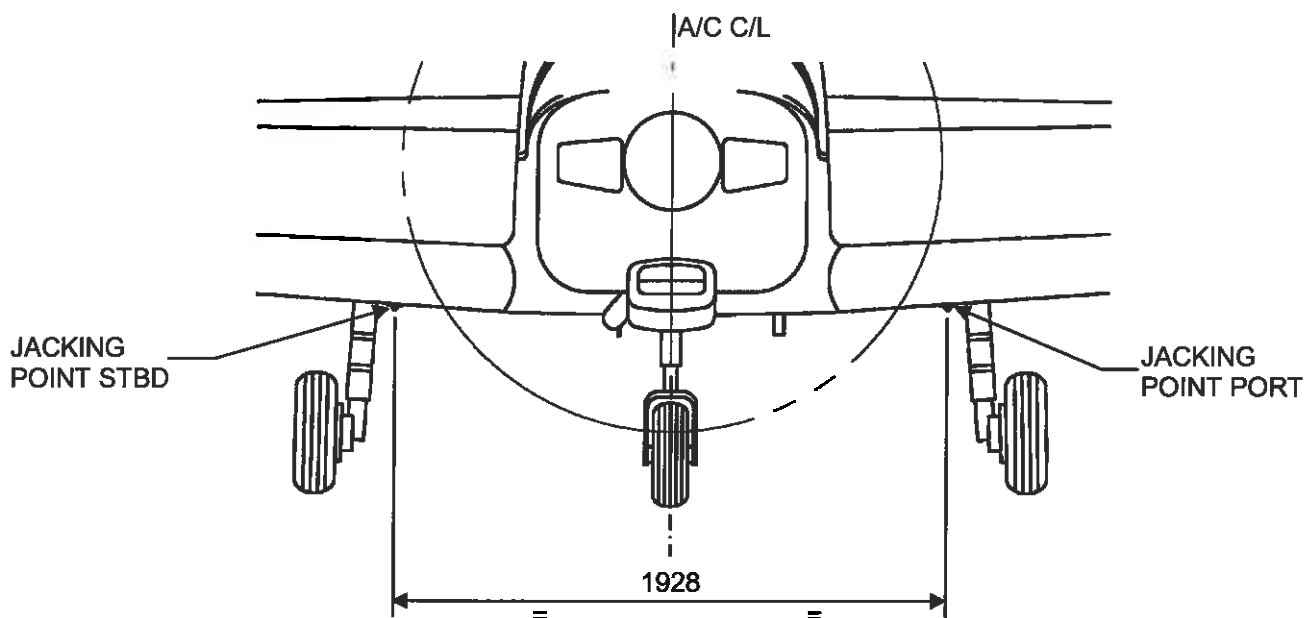
FIGURE 1
SHOWING JACKING POINT POSITION

- 1 Gain access to underside of wing and inspect for two jacking points 1 port, 1 stbd at positions indicated by Figure 1.
- 2 If there are Jacking Points on underside of wing, check for security. Use a light hammer (reference Marshall Slingsby hammer, T67G-88-529, illustrated in relevant aircraft's Maintenance Manual paragraph 2.7.1.2 or equivalent) and gently tap; fore/aft, side to side. Do not use excessive force as this will damage structure. Complete the attached form at Annex A and return it to the address provided.
