Service Bulletin

S.B. No: 194

Title: INSPECTION OF SAB T9S MAIN UNDERCARRIAGE LEGS FOR CRACKS IN WING MOUNTING PORTION

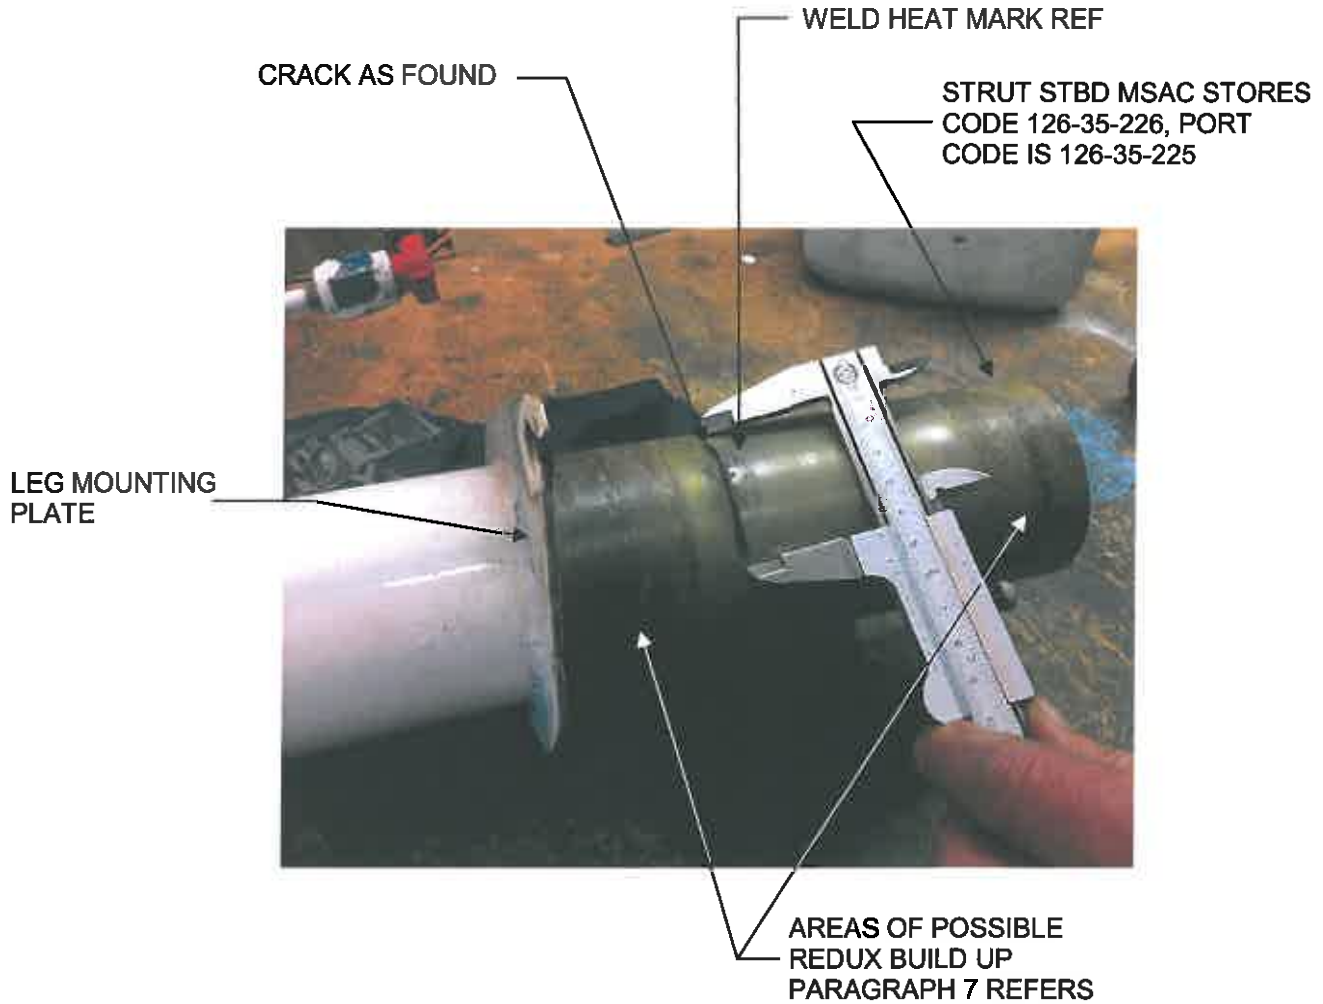
PHOTOGRAPH 1

A maintenance organisation has reported a crack in the aft face of the SAB T9S main undercarriage leg (Pre Mod M468) at the top of the leg, refer Photograph 1. This crack measures 40mm overall by 10 micron wide.

The water ingress was due to the poor sealing surfaces of the wing at the oleo cover, and water finding its way into the wing undercarriage mounting structure due to the crack in the leg.

GENERAL VIEW OF CRACK FOUND ON SAB MAIN LEG FIXED STRUT

- 1 Remove undercarriage legs IAW relevant aircraft's Maintenance Manual (MM).
- 2 Clean all external and internal surfaces and in the first instance check visually the external surfaces for any crack at the collar weld positions above the mounting plate, i.e. the upper part of the strut, see Photograph 1 and Figures 1 and 2. If crack/s is/are visible, scrap strut and replace with new item 126-35-225 Port and/or 126-35-226 Starboard.

- 5 If any cracks are found in the areas dictated for inspection then the fixed strut is to be scrapped and a serviceable replacement is to be sourced. On receipt of replacement strut remove components from old leg and re-assemble into replacement strut IAW relevant aircraft's MM.

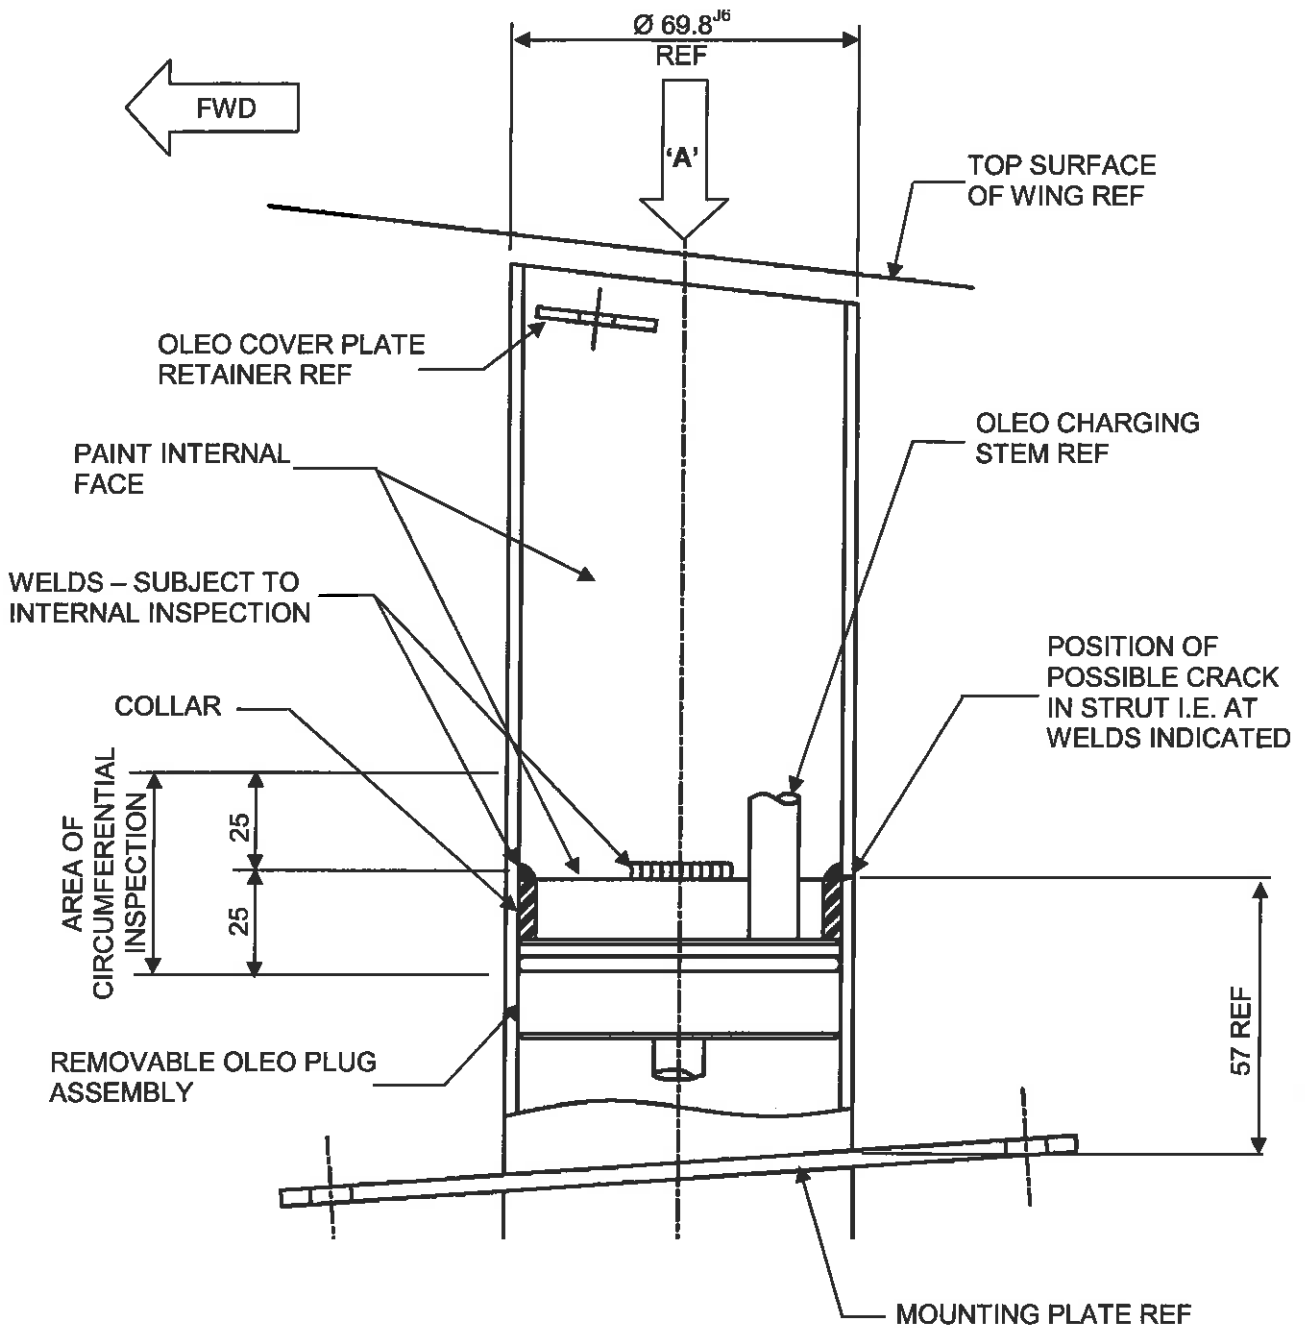
FIGURE 1

PART SECTION THRU TOP OF SAB MAIN LEG
 (TYPICAL PORT & STBD)

- 6 On satisfactory inspection - i.e. no cracks located - ensure all dye penetrant material is removed and internal area indicated by Figure 1 is painted using white epoxy paint system. Ensure external mounting area is primed with epoxy primer.

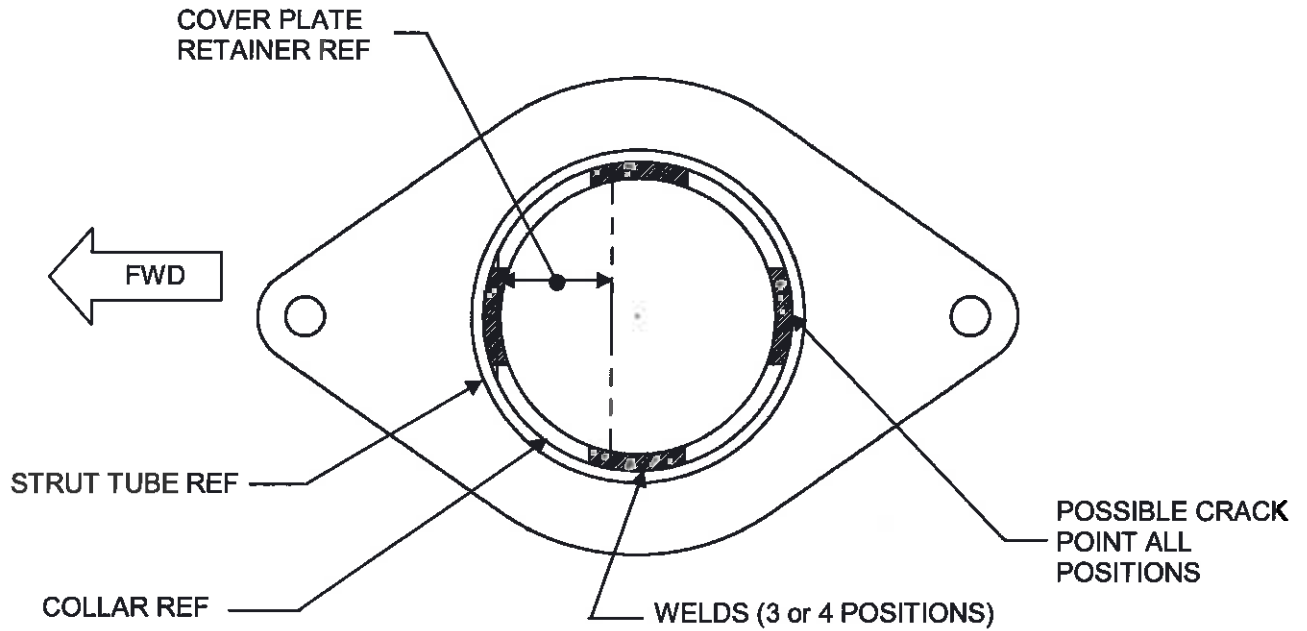
FIGURE 2
VIEW ON ARROW 'A'
SHOWING WELD POSITION

- 4 Prepare areas for initial NDT testing using dye penetrant procedures. Ensure areas for NDT test are cleaned and washed thoroughly. The external area subject to inspection should encompass the full circumference of the leg and extend 25 mm either side of the plane containing the collar welds. The internal inspection should centre on the welds.
