## SERVICE BULLETIN

### INSPECTION OF SLINGSBY T67M260 FIREFLY AIRCRAFT AIR CONDITIONING COMPRESSOR MOUNTING BRACKET FOR CRACKS

Slingsby T67M260 Firefly Post Mod 501 (Air Conditioning Fit) Works Numbers 2234, 2235, 2266, 2268 – 2274, 2276, 2277, 2279 – 2284.

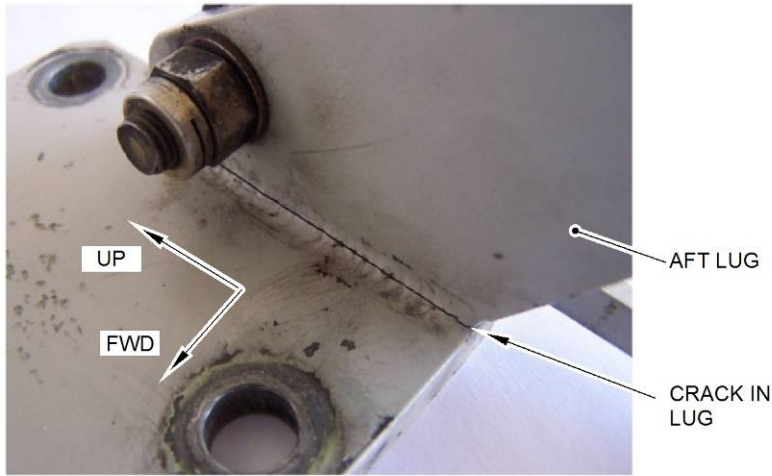
PHOTO 1 FIRST AFFECTED AIRCRAFTS BRACKET

During an audit inspection, Engineering Report ER/MSAC(T67)/12/0379 refers, a failed air conditioning compressor mounting bracket lug was found. Upon further inspection it was noted that the lug weld had appeared to have cracked through completely without any sign of fretting. A fleet inspection was undertaken and a second bracket was found to be cracked but in its base plate. Refer to photographs 1 and 2 for the first affected aircraft's bracket and photograph 3 for the second affected aircraft's bracket.

- (3) If bracket is cracked replace with new bracket, part number T67G-74-203.
- (4) If the bracket is not cracked ensure all dye penetrant materials have been washed away and thoroughly dried prior to protecting areas of removed paint with a clear high temperature petroleum resistant lacquer, apply iaw manufacturers instructions.

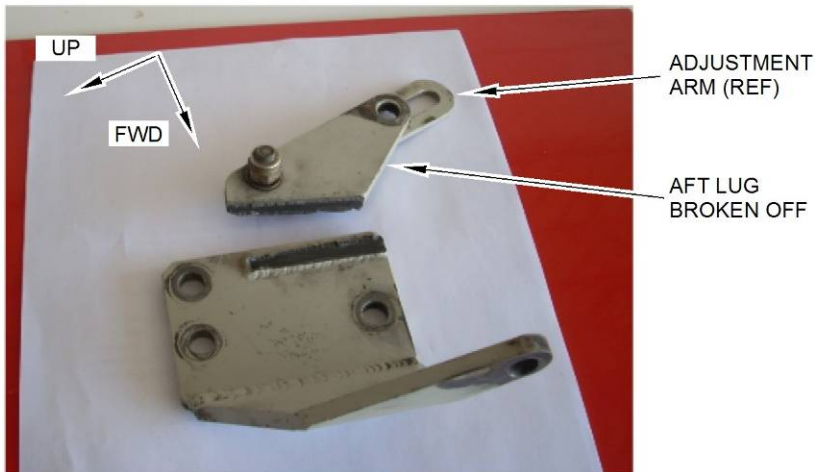
PHOTO 2 FIRST AFFECTED AIRCRAFTS BRACKET

- (2) If no obvious cracking or damage visible, chemically remove paint over inspection areas (Ref Fig 2) (do not use mechanical means; e.g. scraper, emery paper, etc). Ensure paint remover has been completely rinsed off from aft lug welds (Ref Fig 1 Photo's 2 and 3) and mounting plate area above lug (Fig 1 Photo 2) and perform dye penetrant (NDT) inspection.
