SERVICE BULLETIN

INSPECTION OF SLINGSBY T67 FIREFLY PROPELLER SPINNER SUPPORT DISC FOR RUBBER CONDITION

Slingsby T67M, T67M-MkII, T67M200 and T67M260 Firefly Variants

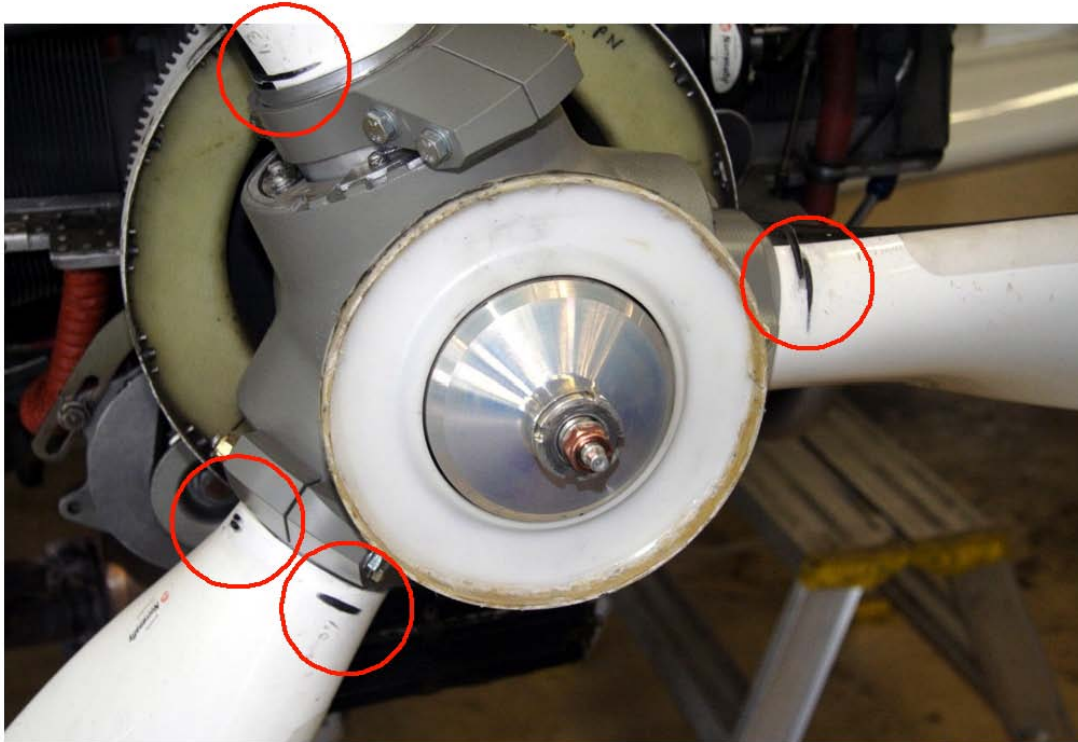
Figure 1 Areas of inspection

A maintenance company noted grooves in the root of the aircraft's propeller blades when performing the 150 flying hour check on a T67M200. Further investigation noted movement in the spinner cone and when the spinner was removed, it was seen that the spinner cone's supporting disc rubber had broken free, allowing excessive movement of the spinner cone, such that the cone contacted the blade roots creating grooves.

- (1) Inspect the roots of the propeller blades, for spinner contact, Figure 1 shows.
- (2) For any blade showing contact, evidenced by paint removal down to the blade structure, the propeller is to be removed and returned to Hoffmann or Hoffmann approved agent, for further inspection/repair. Remove propeller iaw aircraft Maintenance Manual paragraph 8.1.1 (4), (5) plus for the T67M260 paragraph (6).
- (3) Check condition of spinner support disc rubber for perishing (cracks and brittleness), rubber bond integrity to the support disc and rubber wear, Figure 2 shows (T67M200 and T67M260).

AREA OF GROOVING ON PROPELLER

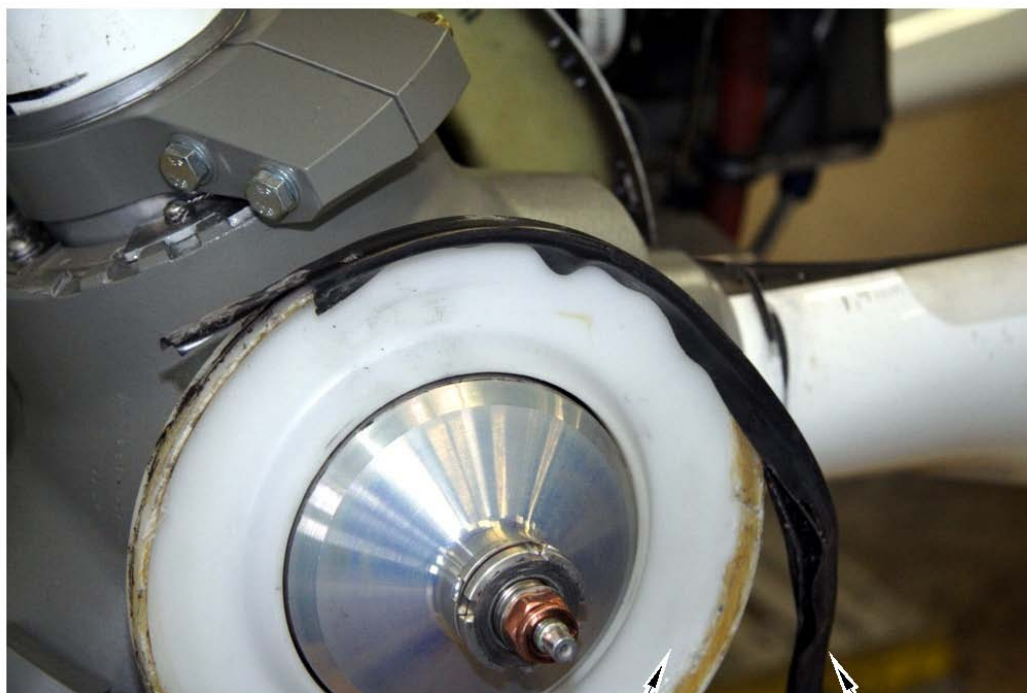
Figure 2 De-bonded rubber strip (T67M200)

SPINNER SUPPORT DISC

RUBBER STRIP
DE-BONDED

- (4) Should rubber exhibit any defect as described in (3) above it should be removed and replaced.

NOTE For T67M and T67M-MkII; use MSAC code number 126-15-116, and for T67M200 and T67M260; use MSAC code number 126-15-131. Ensure surfaces are free from rubber and adhesive, degrease and remove any dust from surfaces to be bonded. Apply adhesive 126-51-211 (3M PR 1300L) iaw manufacturer's instructions and allow to cure.
