SERVICE BULLETIN

SB No. 139^a Issue No. 1

TITLE INSPECTION OF STEERING ARM ON FAIREY HYDRAULICS NOSE LEG

NOSE LANDING GEAR ASSEMBLY 5009H1

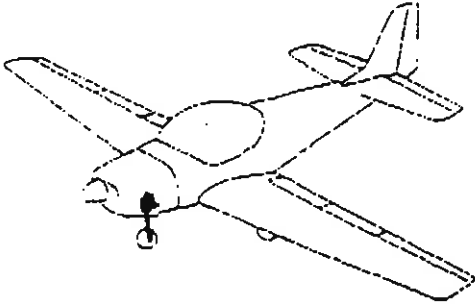
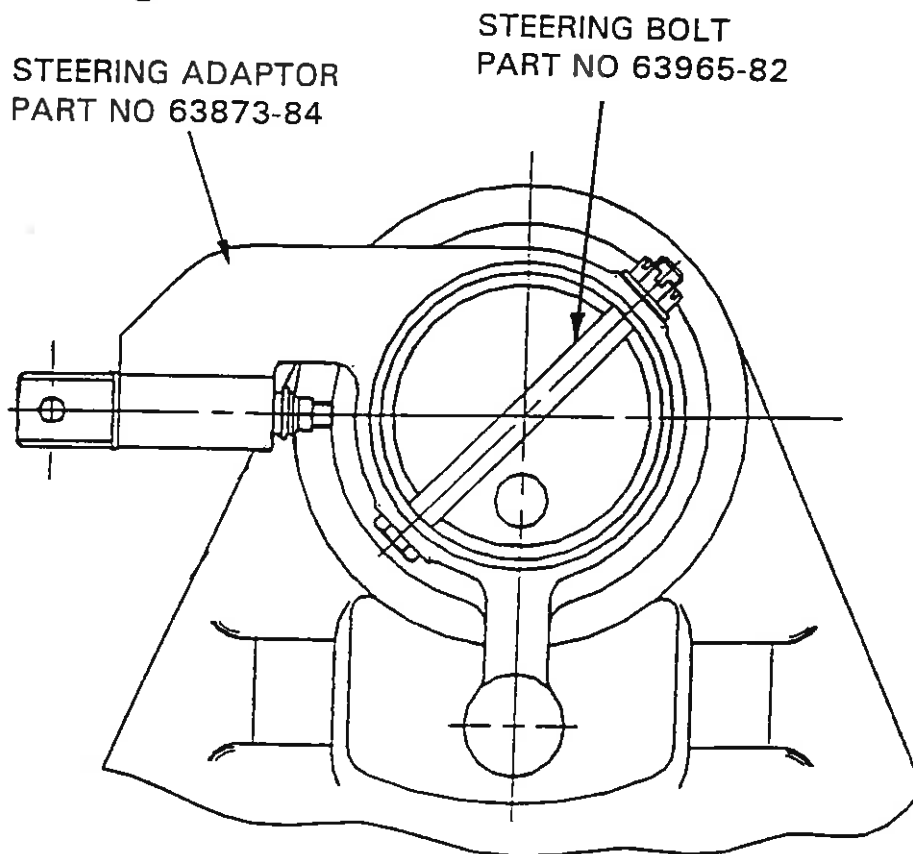
Figure 1 View on top of Nose Landing Gear assembly

There have been occurrences of minor cracks in the steering adaptor in the following areas (Refer Fig.1 and 2)

- the fillet which joins the integral steering arm and the location ring of the adaptor
- radiating from the holes through which the steering bolt passes

Visual inspection of parts on all nose landing gear assemblies in the position indicated in Fig.1 and 2 of this Service Bulletin.

Immediate inspection of the defined area. If a crack is discovered the continued monitoring of the crack every 25 flying hours or replacement of parts.

(1) No cracks found

- a. Refit Nose Landing Gear Assembly and parts to the aircraft in accordance with the Aircraft Maintenance Manual.

(2) Cracks found

- a. Cracks not exceeding 0.2 in (5.08 mm)

- (1) Refit parts and Nose Landing Gear Assembly to the aircraft in accordance with the Aircraft Maintenance Manual.

- (2) Repeat inspection every 25 flying hours.

- b. Cracks exceeding 0.2 in (5.08 mm)

- (1) Return defective parts to Fairey Hydraulics Ltd.

- (2) Fit new steering adaptor (Part No 63873-84) and steering bolt (Part No 63965-82).

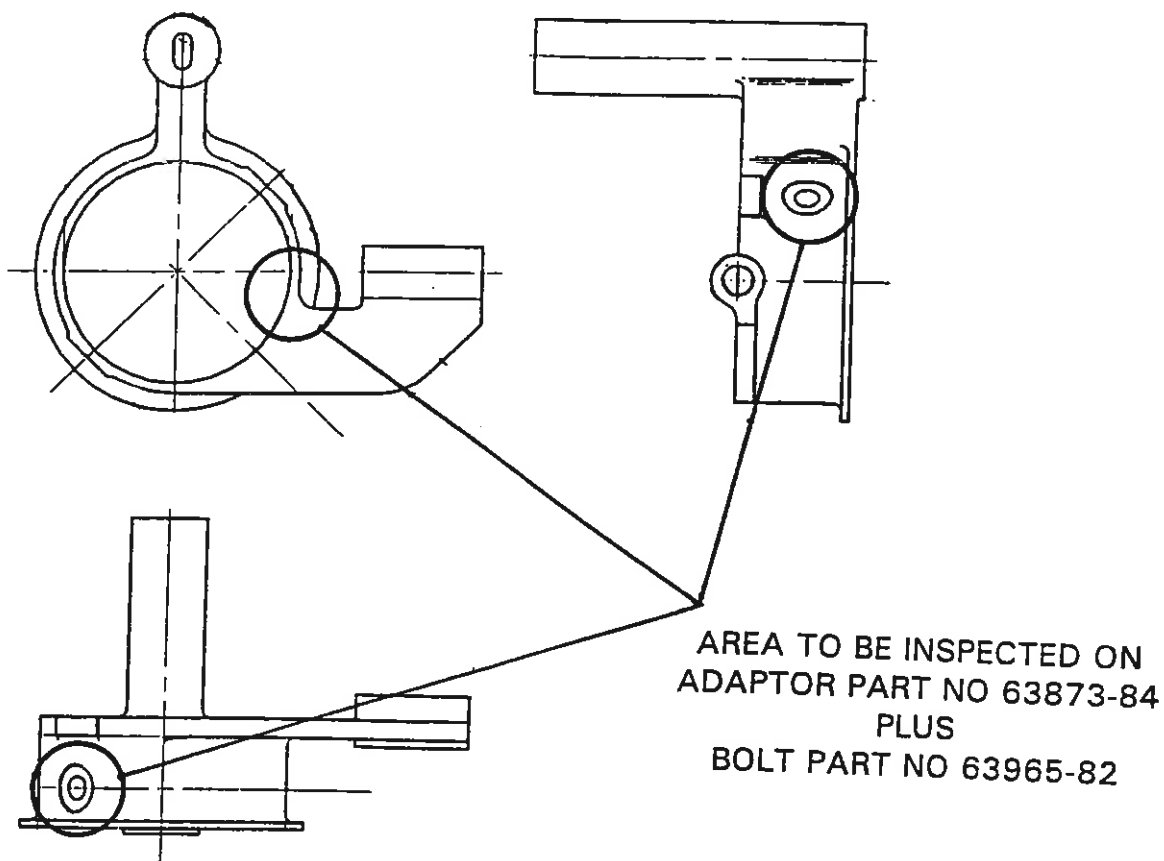
Figure 2 Identification Area

- (1) Refer to Aircraft Maintenance Manual and remove Nose Landing Gear Assembly from the aircraft. Provided personal and equipment safety is assured the Nose Landing Gear Assembly can be retained and supported in the aircraft while the steering adaptor and bolt are removed for inspection.
- (2) If required clean the steering adaptor (Part No 63873-84) and steering bolt (Part No 63965-82) in accordance with local instructions. Particularly, observe local Health and Safety Instructions in the use of solvents.
- (3) Using a torch, mirror and magnification visually inspect (Refer Fig 1 and 2):
 - the steering adaptor for cracks. Particular attention is to be made to the machined fillet that joins the integral steering arm and the location ring of the adaptor and the area surrounding the holes through which the steering bolt is fitted (internal and external faces)
 - the steering bolt

It is recommended that dye penetrant flaw detection is used.
