S.B. No: 176

**Title:** INSPECTION FOR FITMENT OF CORRECT STIFFNUT ON NOSEWHEEL AXLE

NUMBER 32-23, ISSUE 1

**TO CHECK THAT THE CORRECT STANDARD OF  
STIFFNUT HAS BEEN INSTALLED ON THE AXLE BOLT**

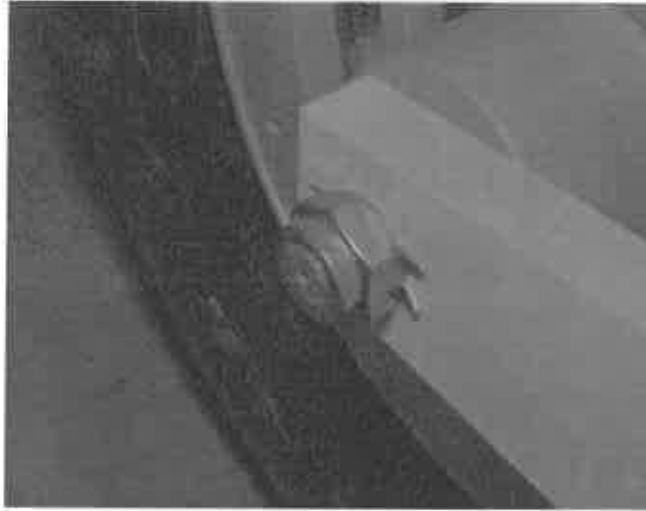
Fig 1 Nut Part No FPY109-10 – correct type

- 1 Make sure the aircraft is safe to work on.
- 2 Refer to Figures 1 and 2 and determine which type of stiff nut is installed to secure the axle bolt to the fork. The correct standard of stiff nut is thinner and does not have a nylon insert that can be seen in the installed position. The correct stiff nut will allow approximately one thread to protrude beyond the end of the nut. The incorrect

standard of stiff nut will show the threads of the axle bolt below the end of the nut. If the correct standard of stiff nut is installed no further action is required.

- 3 If the installed stiff nut is not the correct standard refer to the AMM procedures for the removal of the nose wheel and replace the stiff nut. Make sure the new stiff nut is installed with a new tab washer and that the second tab washer under the head of the axle bolt remains in safety.
- 4 Carry out a duplicate inspection to make sure the head of the axle bolt and the stiff nut are in safety.

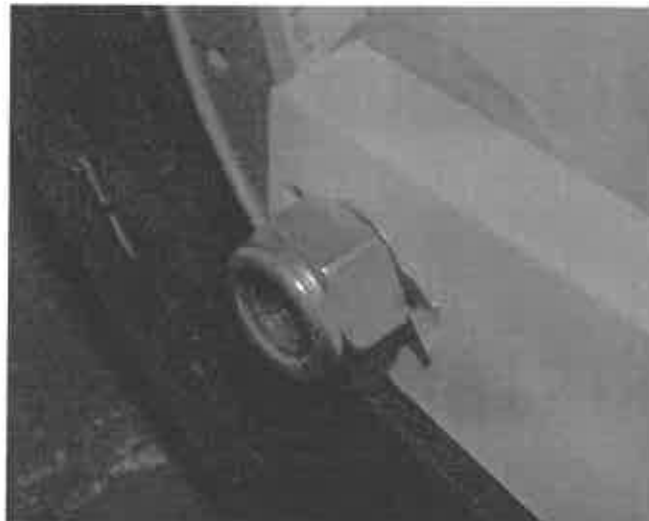
Fig 1 Nut Part No FPY109-10 – incorrect type
