**SERVICE BULLETIN**

SB No. 039

**TITLE** INSPECTION OF WING REAR SPAR TOP SURFACE TO FUSELAGE FAIRING CLEARANCE**CLASSIFICATION** This Service Bulletin has been classified as optional by the U.K. Civil Aviation Authority.**COMPLIANCE** Within the next 150 flying hours, or 3 months from date of this Service Bulletin, whichever is earlier.**APPLICABILITY:**

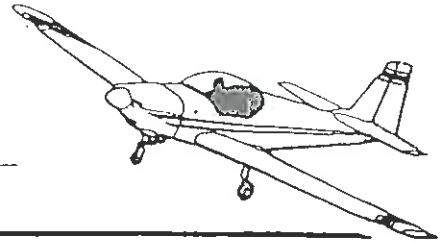
A case has occurred whereby the clearance between the wing rear spar top surface and the fuselage fairing has been insufficient to prevent contact at high positive load factors. This has resulted in cracking of the fuselage fairing which, although not structurally significant, is undesirable.

POSSIBLE AREAS OF CRACKING IN FUSELAGE FAIRING

1. Inspect the fuselage fairing for cracking adjacent to the wing rear spar.
2. Measure and record the minimum clearance between the wing rear spar top surface and the fuselage fairing. (Port and starboard) (See Figure 1).
3. Pass details of 1, and 2, above to Slingsby Aviation Ltd.
