# SERVICE BULLETIN

SB No. 52 Issue No. 3

**ELEVATOR HORN WATER INGRESS**

T67B, T67C Series, T67M, T67M-MkII, T67M200, T67M260 and T67M260-T3A

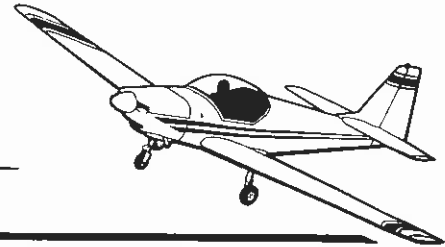
An annual inspection on an elevator had found a quantity of water inside the horn balance.

1. Deflect elevators to up position.
2. By tapping the inside face of the horn balance with a coin, the position of the lead balance weight can be ascertained.
3. Ref. Fig 1 drill 5mm dia hole in the lower skin of the horn in the hollow portion as close to the lead balance as possible.
4. Check the condition of the vinyl disc T67B-00-301 which covers the elevator hinge pivot. Renew as necessary.
5. Annotate logbook SB 52 complied with. Invokes Mod M606.
